Natural Hazards and the Cultural Heritage of Guatemala: An Overview from the Vantage of the Quirigua Archaeological Park¹

Introduction

Case Study: Quirigua Archaeological Park

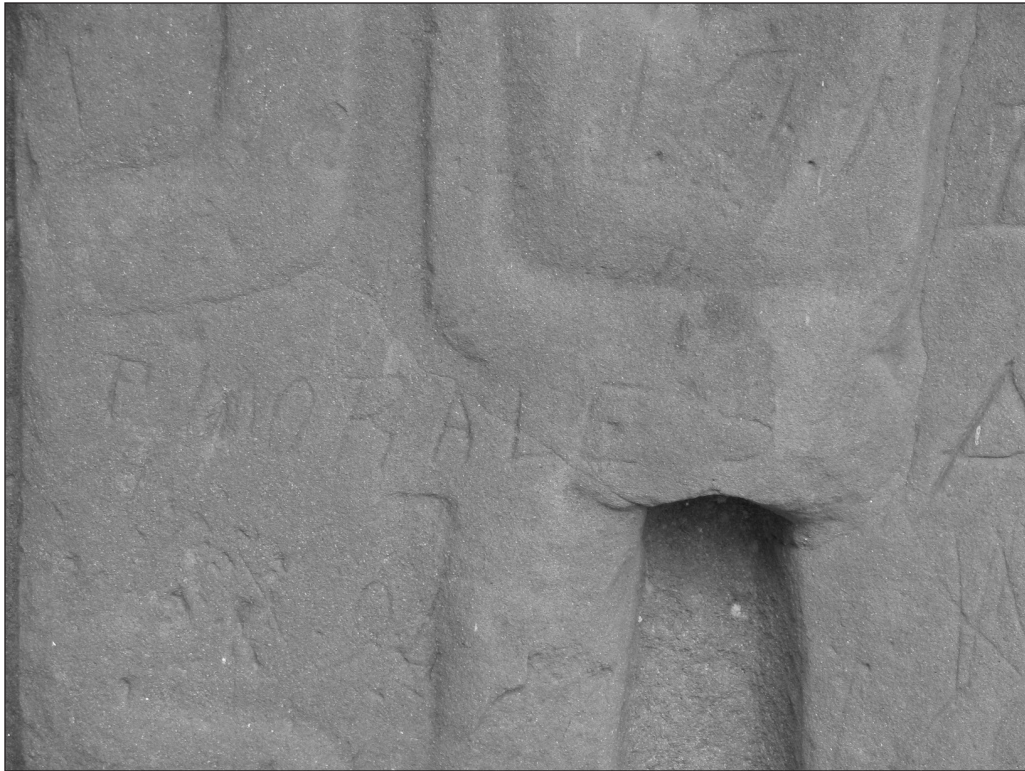
Figure 4. Anthropogenic damage to monuments: graffito on Stela A of Quirigua (photo: M. Díaz, 2009).

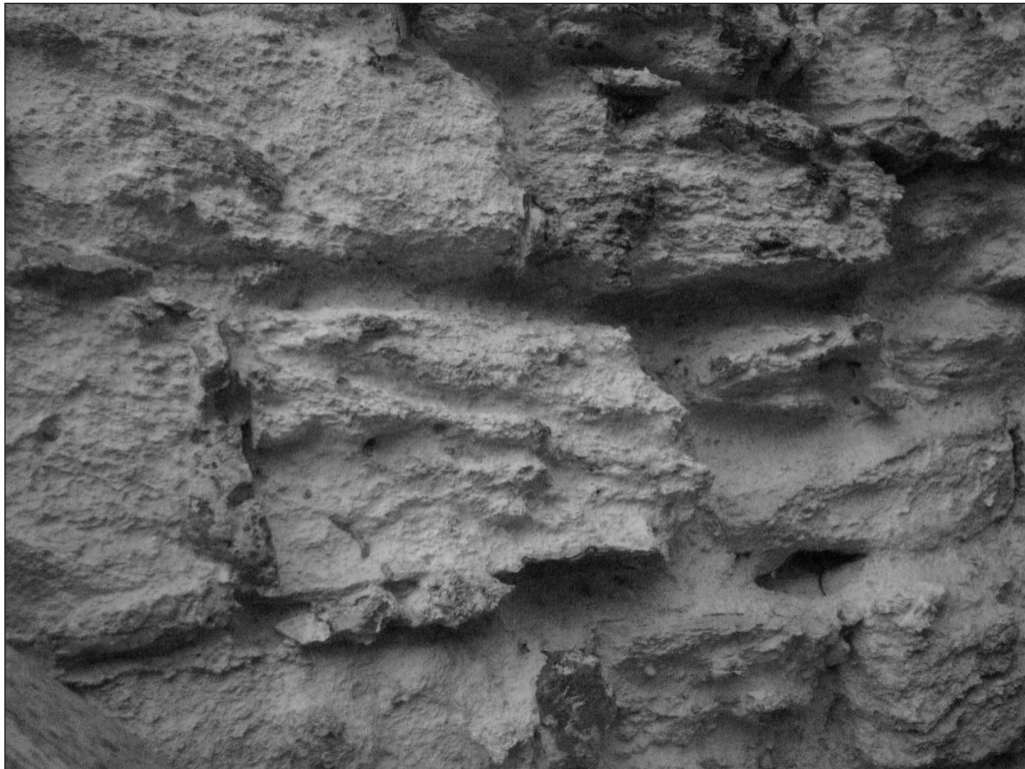
Figure 5. Damage from natural sources: eroded stone wall at Tikal (photo: J. Crasborn, 2010).

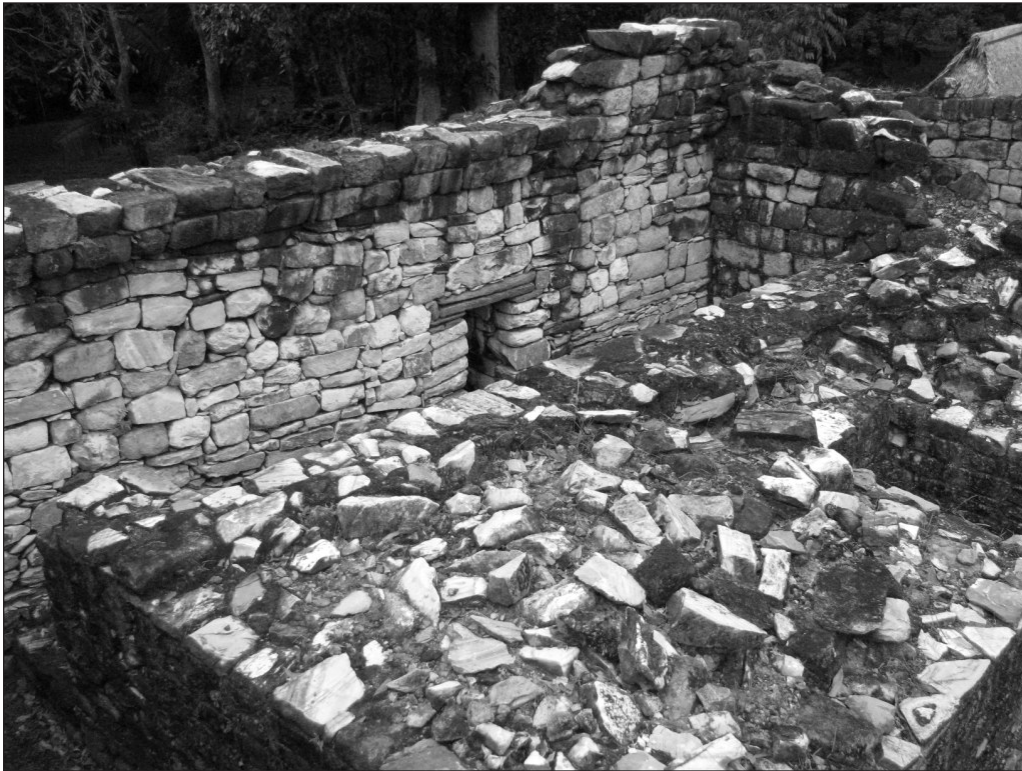
Figure 8. Remaining vault of Structure 1B-4 of Quirigua (photo: J. Crasborn, 2010).

Robert Sharer (1990:76) has argued that from the first reports on Quirigua no author noted any remaining stone roofs at the site, and archaeological research has since confirmed that all of the buildings at the site built with stone vaults had collapsed in ancient times, perhaps from seismic activity (Figure 8). Sharer has pointed out that the presence of buttresses at the base of the main buildings in the site center is a clear example of the kind of modification performed by the ancient Maya to respond to earthquakes and prevent risk of collapse (Figure 9).

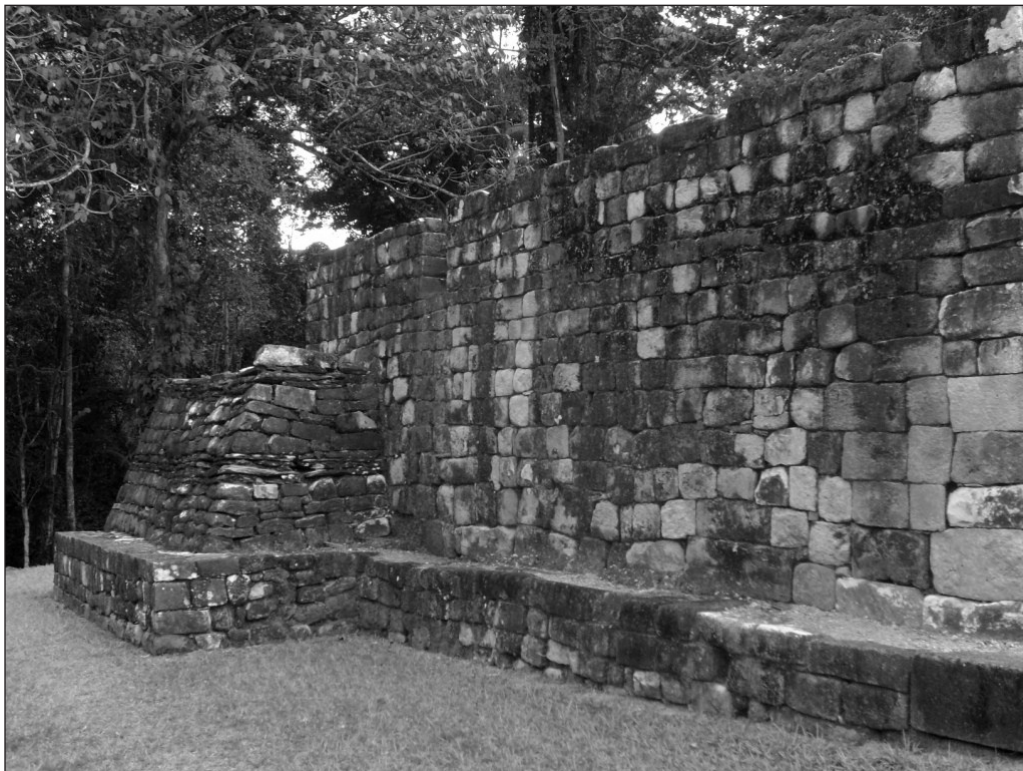
Figure 9. Buttress added to reinforce the walls of Structure 1B-3 of Quirigua (photo J. Crasborn, 2009).

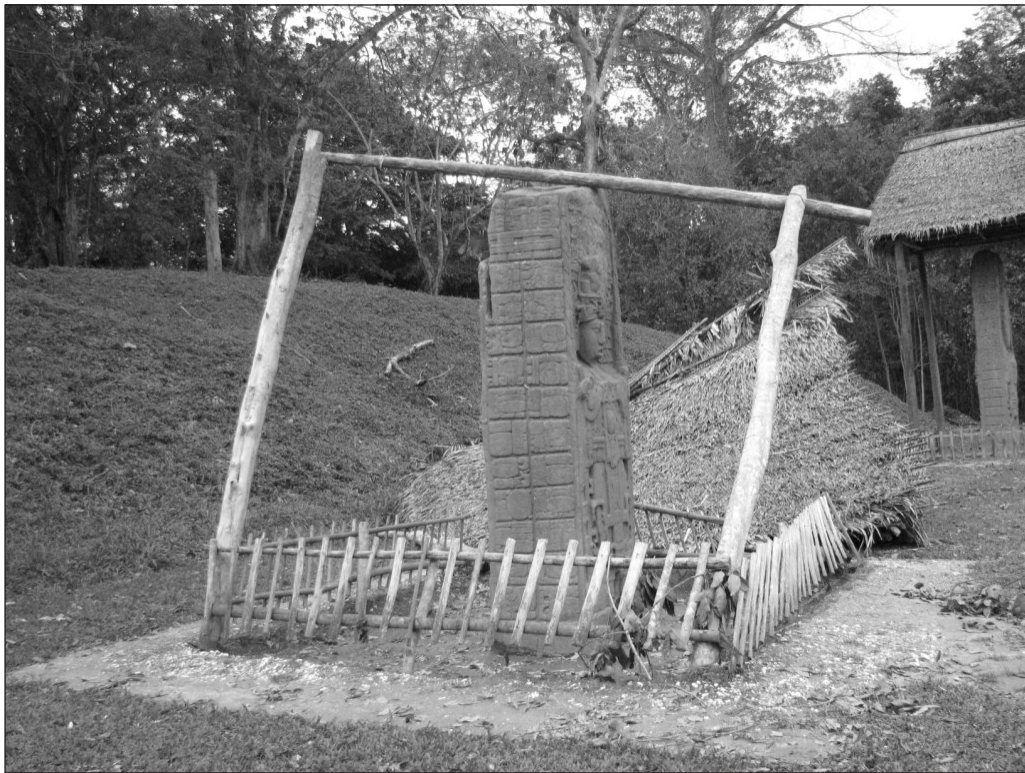
Figure 10. Hurricane damage from April, 2010, caused by the collapse of the thatch shelter over Quirigua Stela A (photo: J. Crasborn, 2010).

As mentioned above, Quirigua is susceptible to many types of disasters, and it is very difficult to take measures to protect the monuments against such events as earthquakes. In the case of hurricanes, the only measure that has been successfully implemented is the regulation of shade or the removal of branches from trees close to monuments, restored architecture, and public use areas, in order to avoid any damage that would occur from their collapse. With regard to flooding, an ambitious project has been initiated that will take time to achieve full results. During Tropical Storm Agatha, for example, it was noted that the perimeter mesh fence functioned as a sieve, not allowing much organic material (e.g., branches) to enter the stream and be carried to other sectors. For this reason, among others, there are plans to strengthen the perimeter fence of the park by building a "living fence" of trees and plants along the inner side of the metal fence, aiming to reduce further the amount of debris that may enter the park during a flood. The Bandegua company has begun the work of strengthening the banks of the Motagua River and has supported the idea of a living fence and may build a second one on its land surrounding Quirigua, which would function

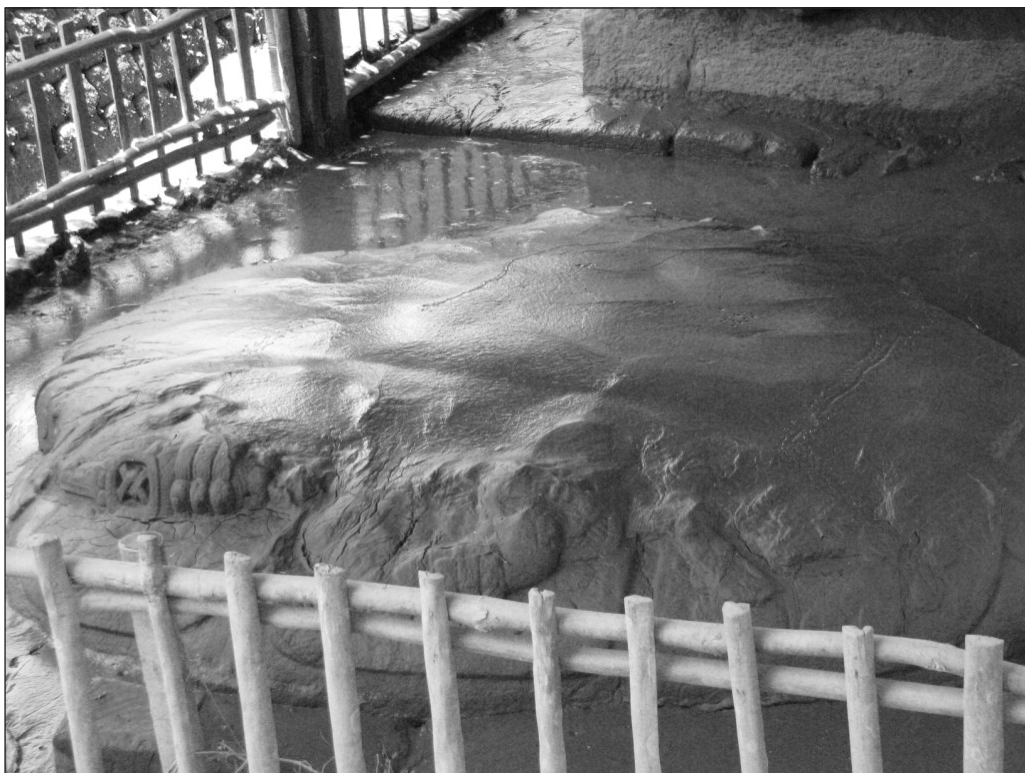
Figure 11. Mud covering Zoomorph O in 2010, the result of flooding at Quirigua from Tropical Storm Agatha (photo: by J. Crasborn, 2010).

monuments and structures, but damage occurred to the park's infrastructure and 0.20 m of sediment was deposited across the site (Figure 11).

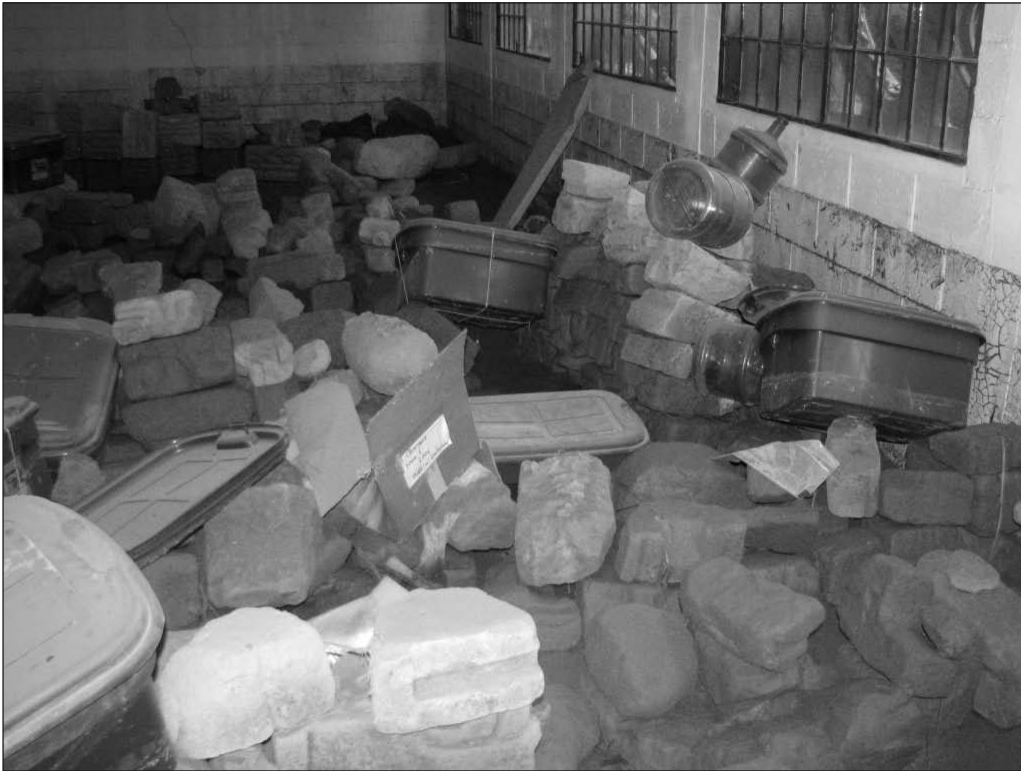
Figure 12. Damage caused by Tropical Storm Agatha in the storage building constructed in 2000 (photo: by J. Crasborn, 2010).

During the archaeological research of the University of Pennsylvania in the 1970s, a camp was built at ground level to be used as a laboratory and warehouse of archaeological materials, which remained until 1998 when Tropical Storm Mitch flooded the park. At this time water and mud entered the building and covered and undermined many of the shelving units, causing considerable damage to archaeological materials in storage, as well as the loss of identification codes and the mixing of materials, with the result that much of the original context and provenience of these artifacts was lost. Because of this situation, in 2000 the Ministry of Culture and Sports began construction of a new storage building, taking into account future flooding by constructing the floor 0.50 meters above ground level. At the time it was

believed this was adequate for future flooding, but Tropical Storm Agatha in 2010 proved that this height was too low, causing further damage (Figure 12).
