THE MERCADO  
CHICHEN ITZA, YUCATAN

KARL RUPPERT

Preprinted from Carnegie Institution of Washington Publication 546, pp. 223-260

October 1943

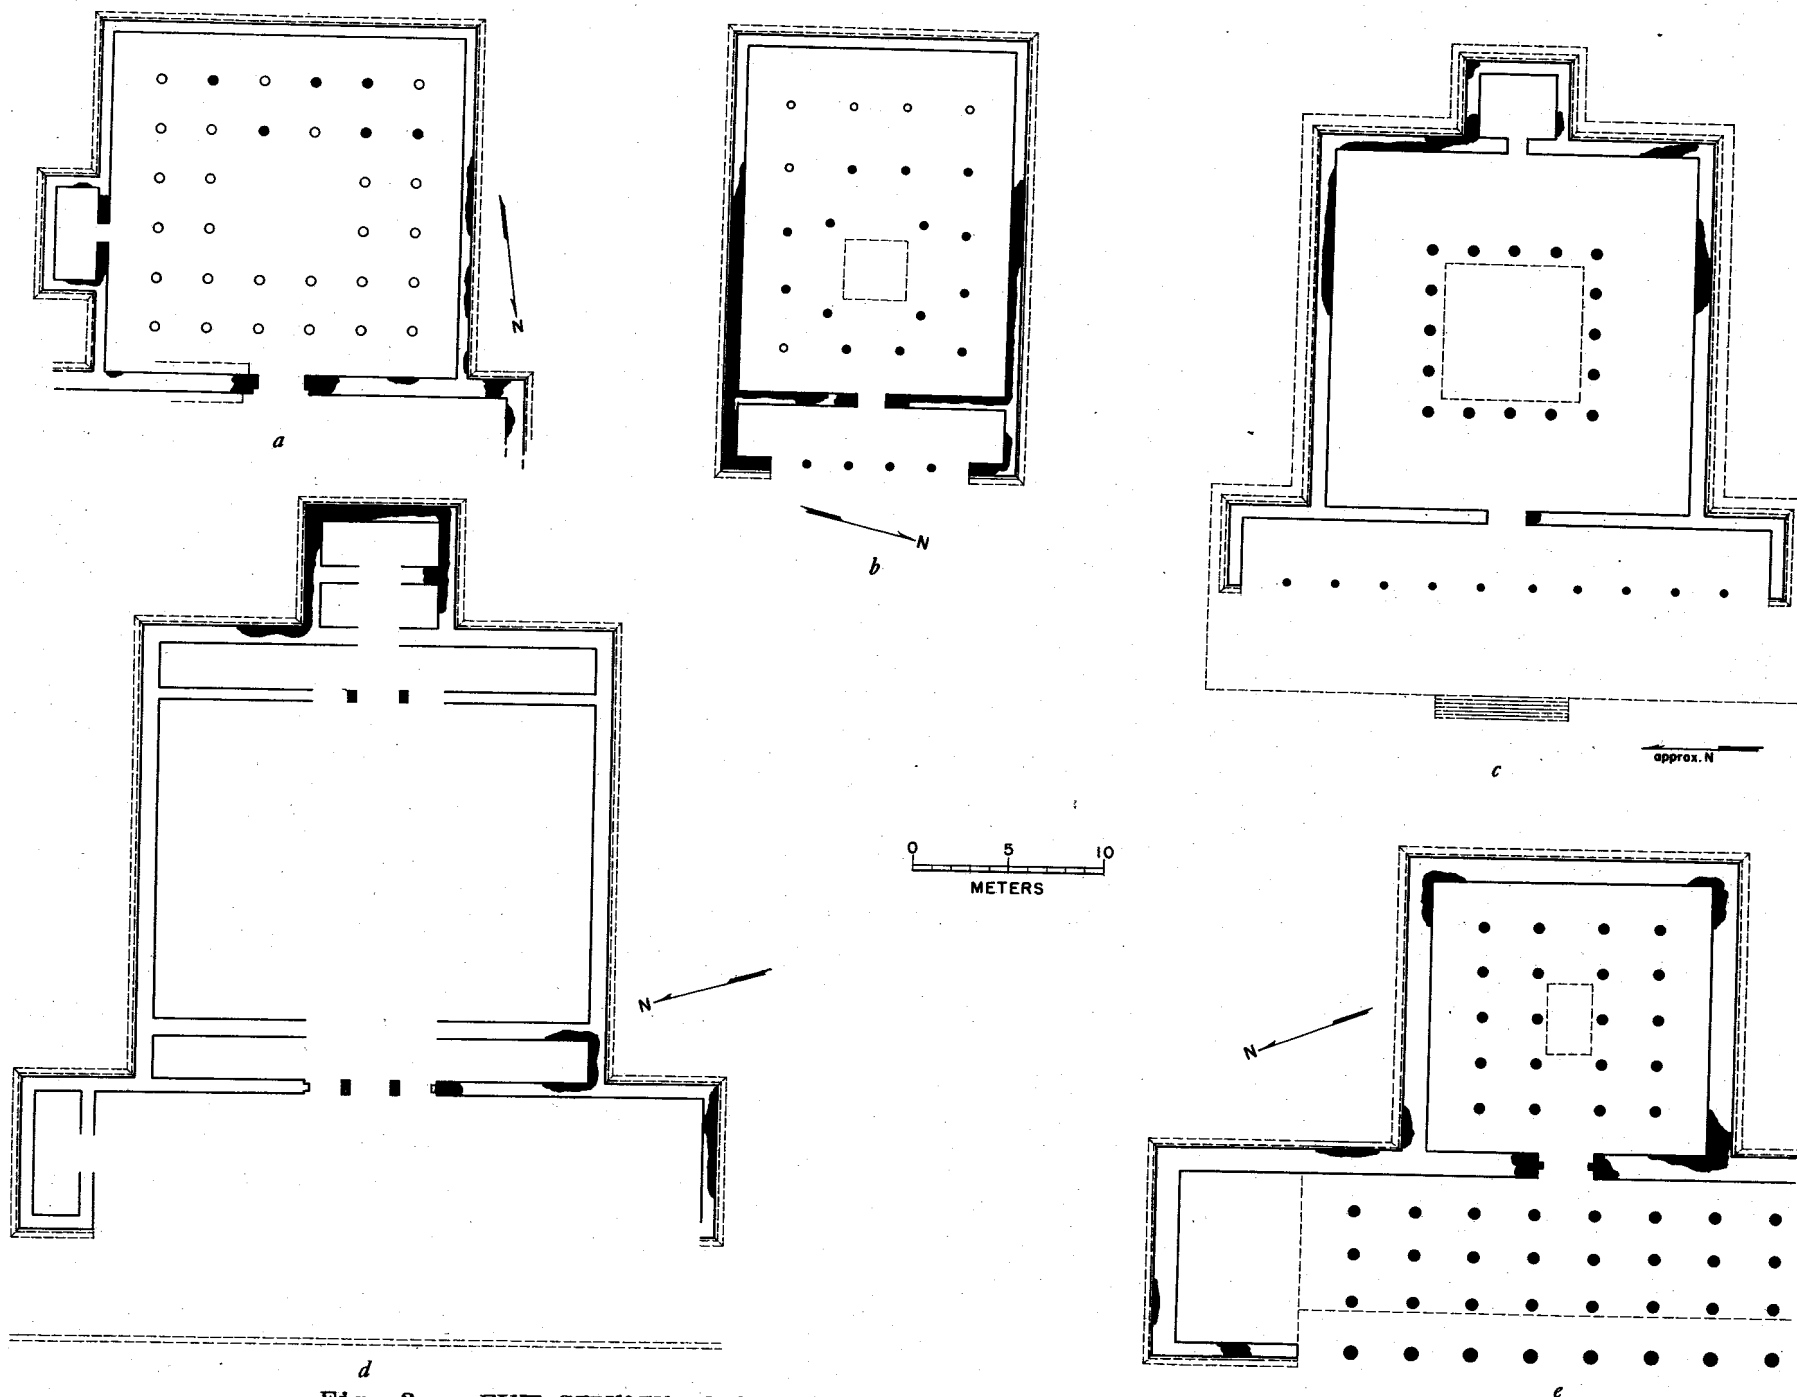
Fig. 3 -- FIVE STRUCTURES OF THE GALLERY-PATIO TYPE AT CHICHEN ITZA

a: Structure 6E3.

d: Structure 5B17.

Only general observations can be made of the second complex in the Southwest Group, 5B17 (fig. 3d), as it is very much in ruin. No columns were seen in the debris along the front of the structure, which in all buildings of this type takes the form of a gallery. The failure to note them can be explained only by their being buried in the debris or having been removed. The depth of the debris at the north end indicates the former presence there of a small chamber.

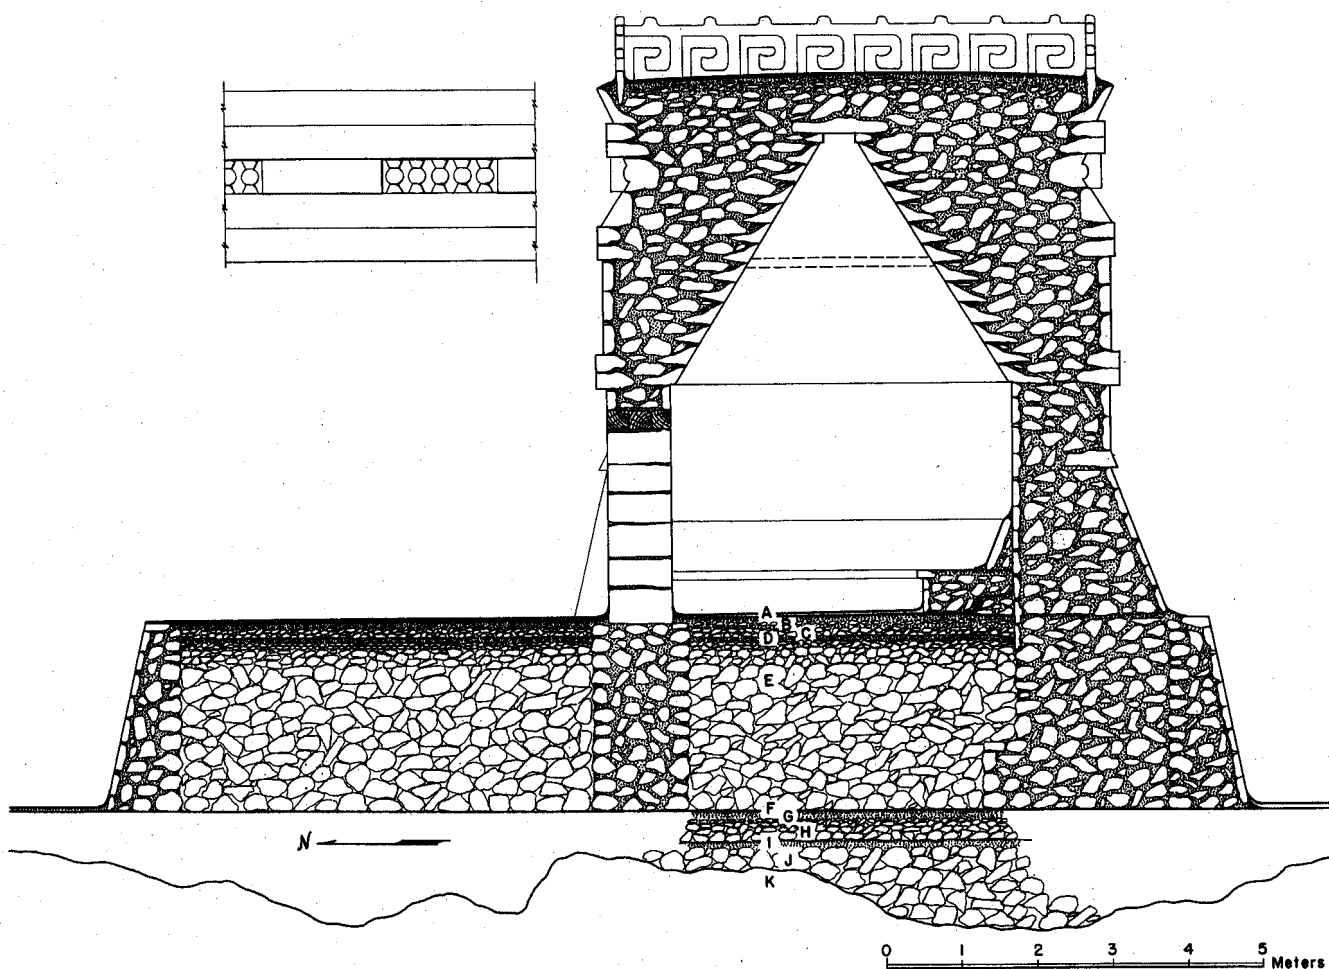
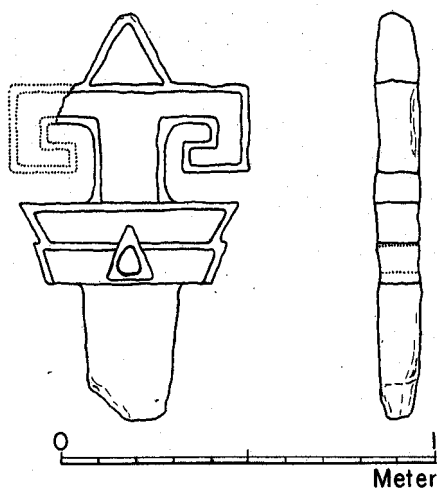
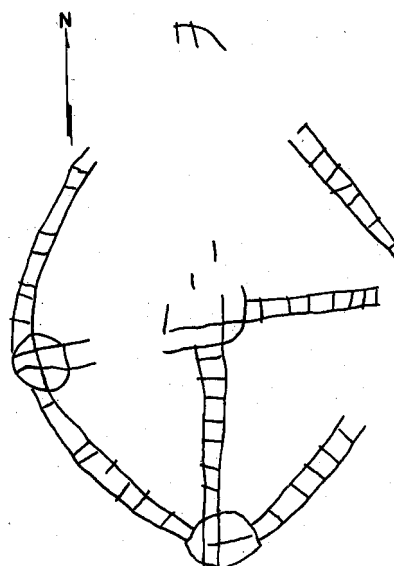
Fig. 4 -- MERCADO AND STRUCTURE 2D6

- a: Masonry section A-B through gallery of Mercado.
- b: Roof decoration from Structure 2D6.
- c: Graffito on gallery bench of Mercado  
(1/10 actual size).

The material south of the foundation supporting the columns continues, for the most part, as loose open fill to the back wall of the gallery. Beneath that wall there is again a section consolidated and strengthened with mortar (fig. 4a). The south retaining wall is of the same mortar-laid masonry, but a distinct vertical line indicates that it was constructed as a separate operation. Where the wall of the gallery forms that of the patio, the south side of the foundation is set outward 50 cm. from the line of the wall.

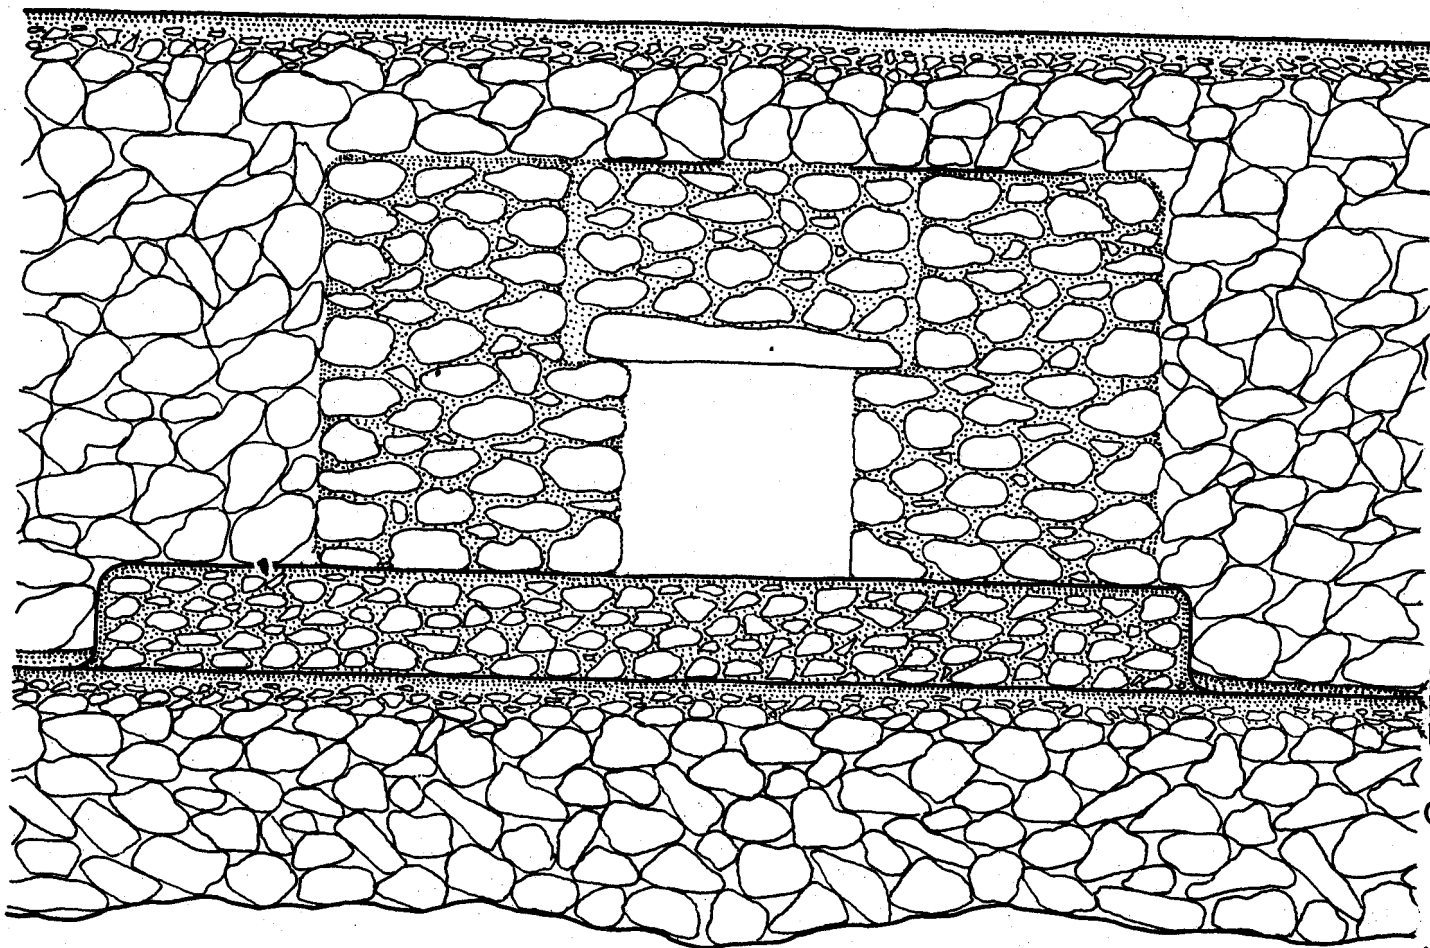
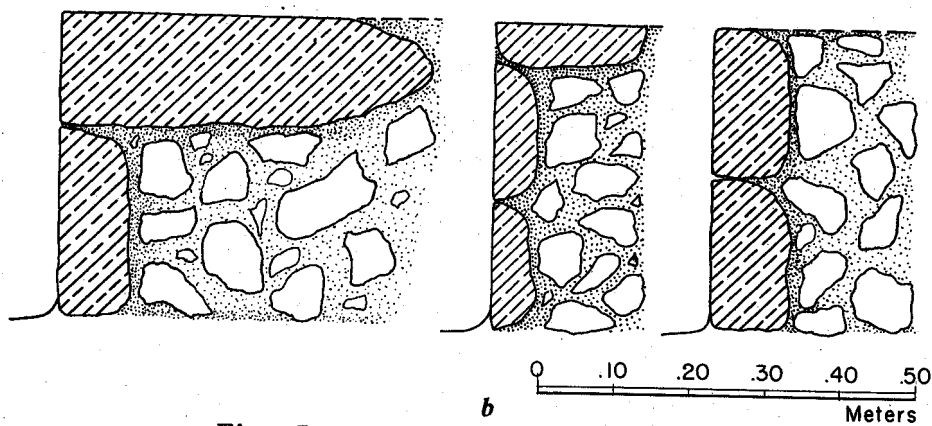
**Fig. 5 -- MASONRY BOX AND STEP**

- a:** Section of masonry box under patio floor.
- b:** Sections showing vertical facing of step from ambulatory to sunken area.

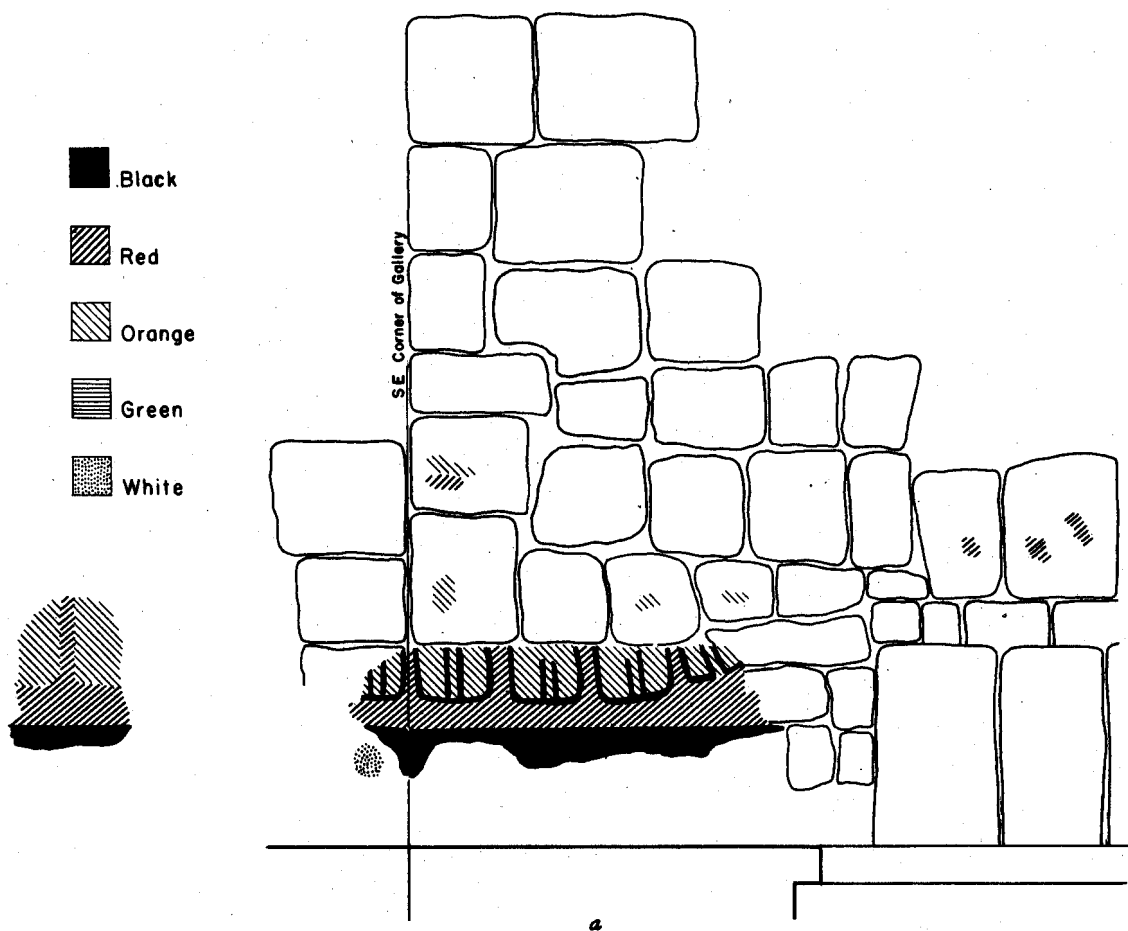
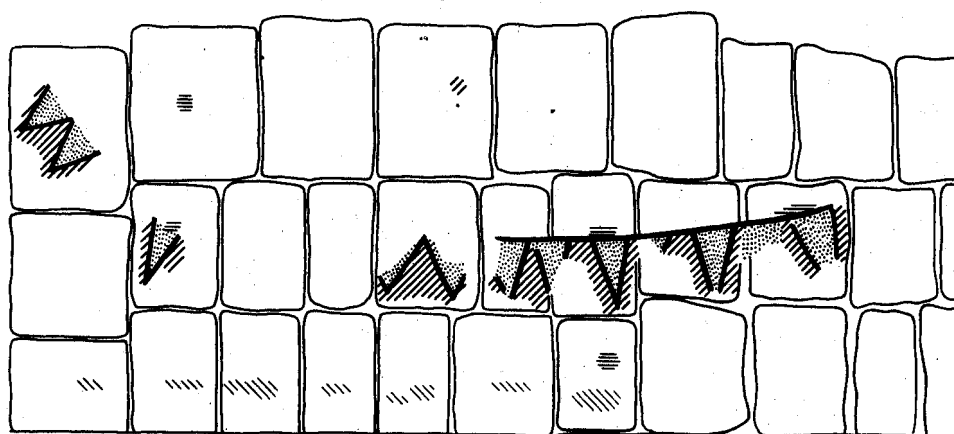
Fig. 6 -- PAINTED DECORATIONS ON WALL OF GALLERY

a: At southeast corner.

b: Behind Columns 6 and 7.

The plaster on the gallery wall above the step had been painted in horizontal bands of green, yellow, black, red, and blue. As noted at different points on the wall there is some variation in the width of the bands as well as in the sequence of the colors. Other decoration remaining consisted of triangular forms in white outlined in black on a red background and may be the serrated border of a serpent body similar to those painted on the walls of the Temple of the Chac Mool. They appear in line with Columns 6 and 7 and have the lower point of the triangle 75 cm. above the inclined element of the bench (fig. 6b).

In the southeast corner are five pairs of ornaments (four on the south wall, one on the east wall) painted in orange and outlined in black (fig. 6a). These are similar to the elements described by Mrs. Morris as "yellow petals" (Morris, Charlot, and Morris, 1931, 1:364) terminating appendages that issue from the curves of the snake. Only the lower 12 cm. of these ornaments were in good condition as that portion was covered and protected by the inclined element of the bench. This would indicate that the wall decorations belonged to a period preceding the construction of the bench.

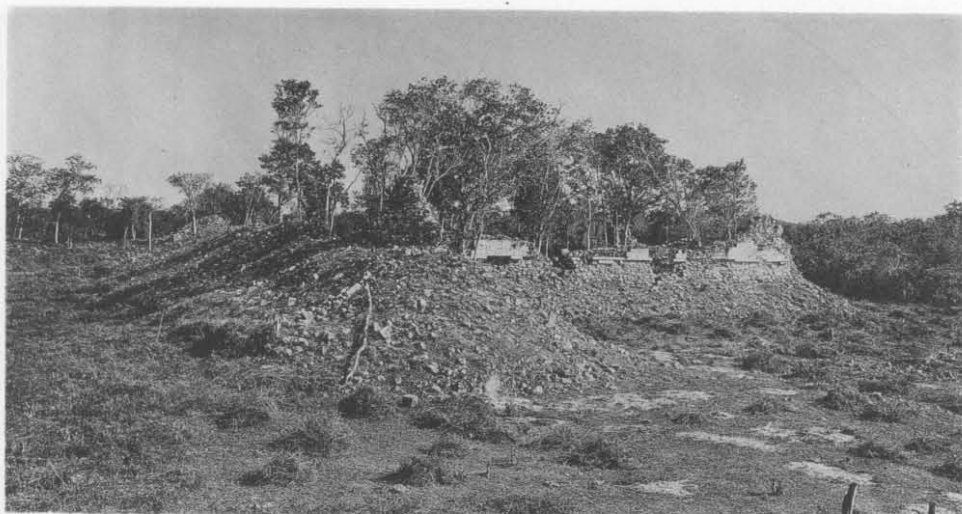
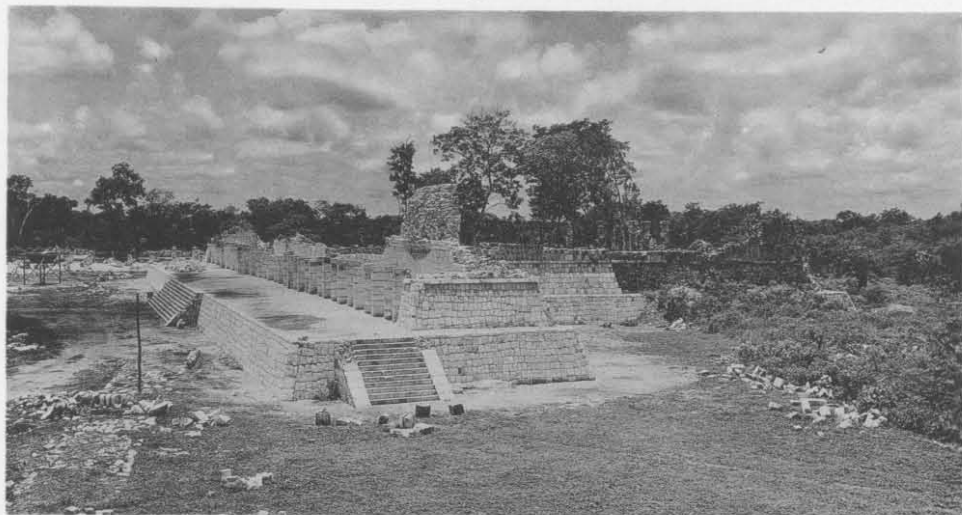
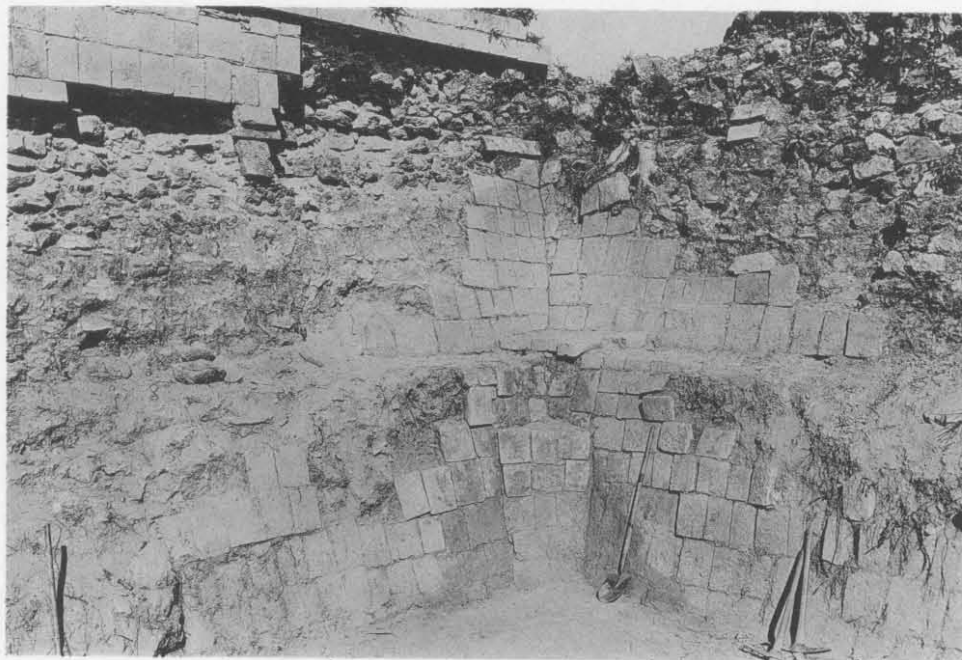
FIG. 9—MERCADO: EXCAVATION AND REPAIR  
*a*: Before excavation, view from northwest.  
*b*: After repair, view from northwest.  
*c*: Corner formed at junction of gallery and west side of patio.

The platform-facing rises at an average angle of 75°. The masonry is veneer-like. The stones are regular, even and worked with the same care as those in other Mexican Period pyramidal structures and terraces; their exposed faces vary from 22 by 35 cm. to 19 by 22 cm. (fig. 9b). They are laid in more or less regular courses; eight are used at the west end. In some places there remain several layers of untinted plaster. Stones of the topmost course average 14 cm. in height and their tenons are 35 cm. long. Such stones, found *in situ* in the corner formed by the junction of the gallery and the west side of the patio platforms (fig. 9c), did not overhang the battered facing. With their long tenons they served to secure and strengthen the upper edge. Exterior corners of the platform are formed of five to seven rounded blocks (fig. 9b).

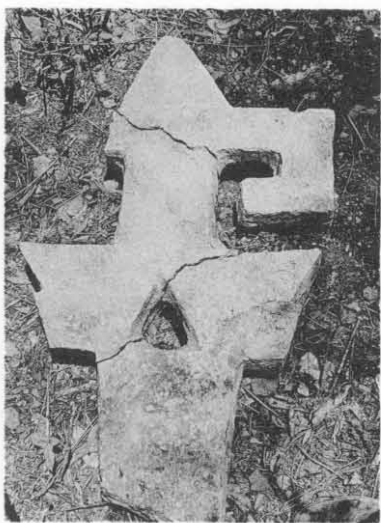
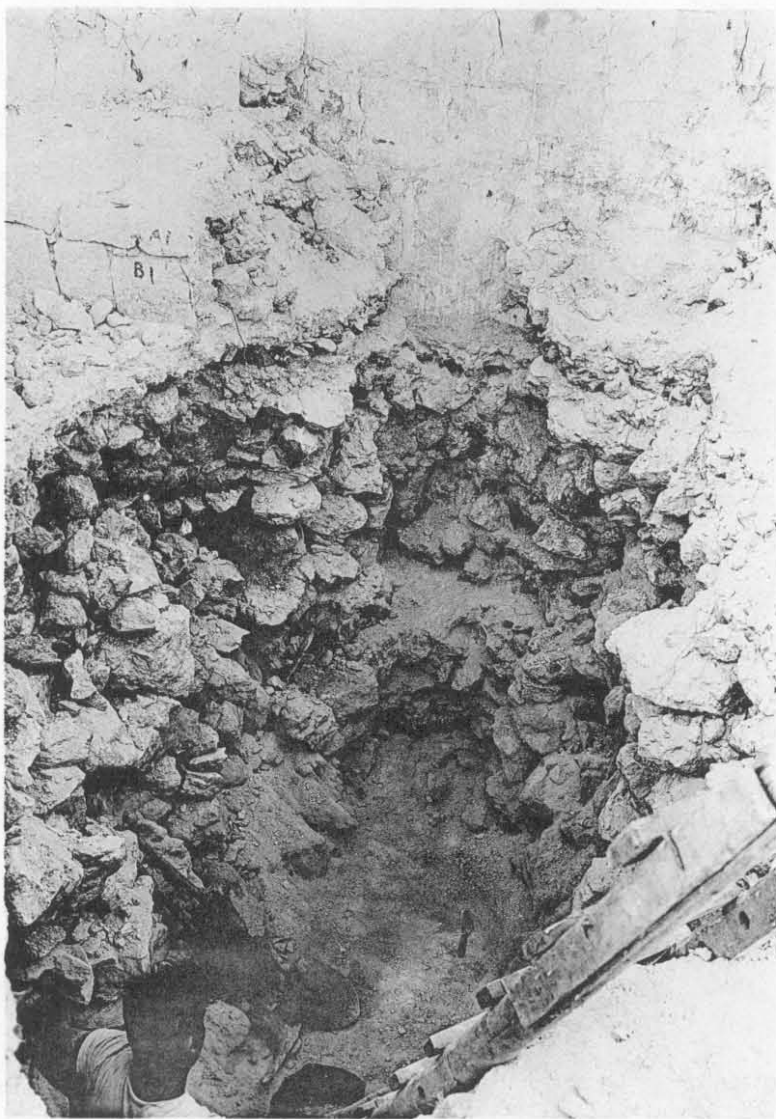
FIG. 10—STRUCTURE 2D6 AND MERCADO GALLERY

*a*: Roof ornament from Structure 2D6.

*b*: Mercado gallery. Trench in platform between Column 6 and back wall.

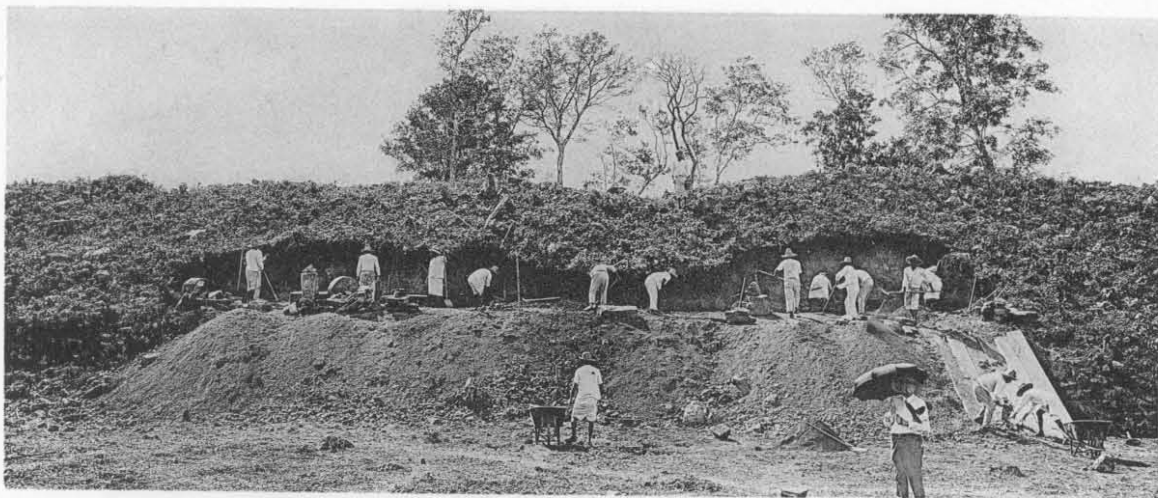
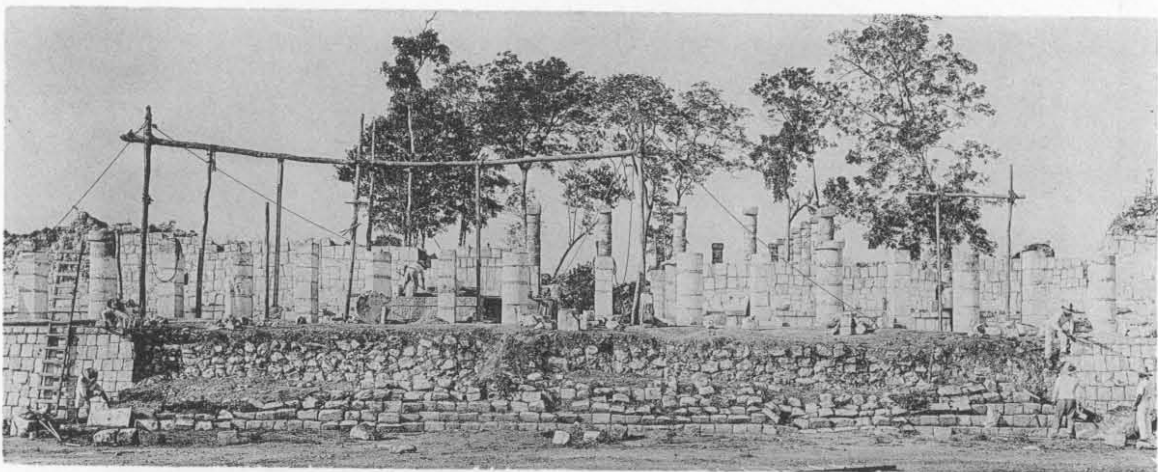
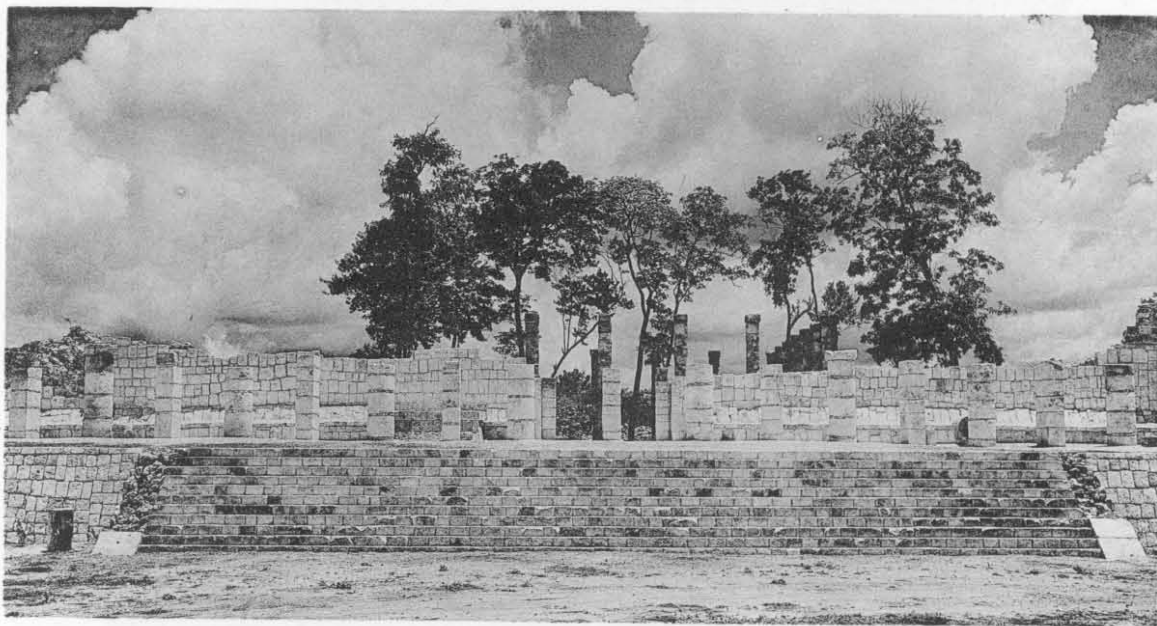
FIG. 11—NORTH STAIRWAY OF MERCADO

*b*: Excavation completed.

*c*: Repair completed.

The main stairway rising to the platform is on the north side. Practically all stones of the first step, many of the second, and a few of the third were found *in situ*; the remainder had been thrust out of alignment or were entirely displaced (fig. 11b). They were generally cut with the vertical face the height of the riser and placed on the long tenon of the stone forming the tread of the step below. Those found at the base of the stairway, where they have been protected from weathering, still showed their original careful workmanship and finish (fig. 11).

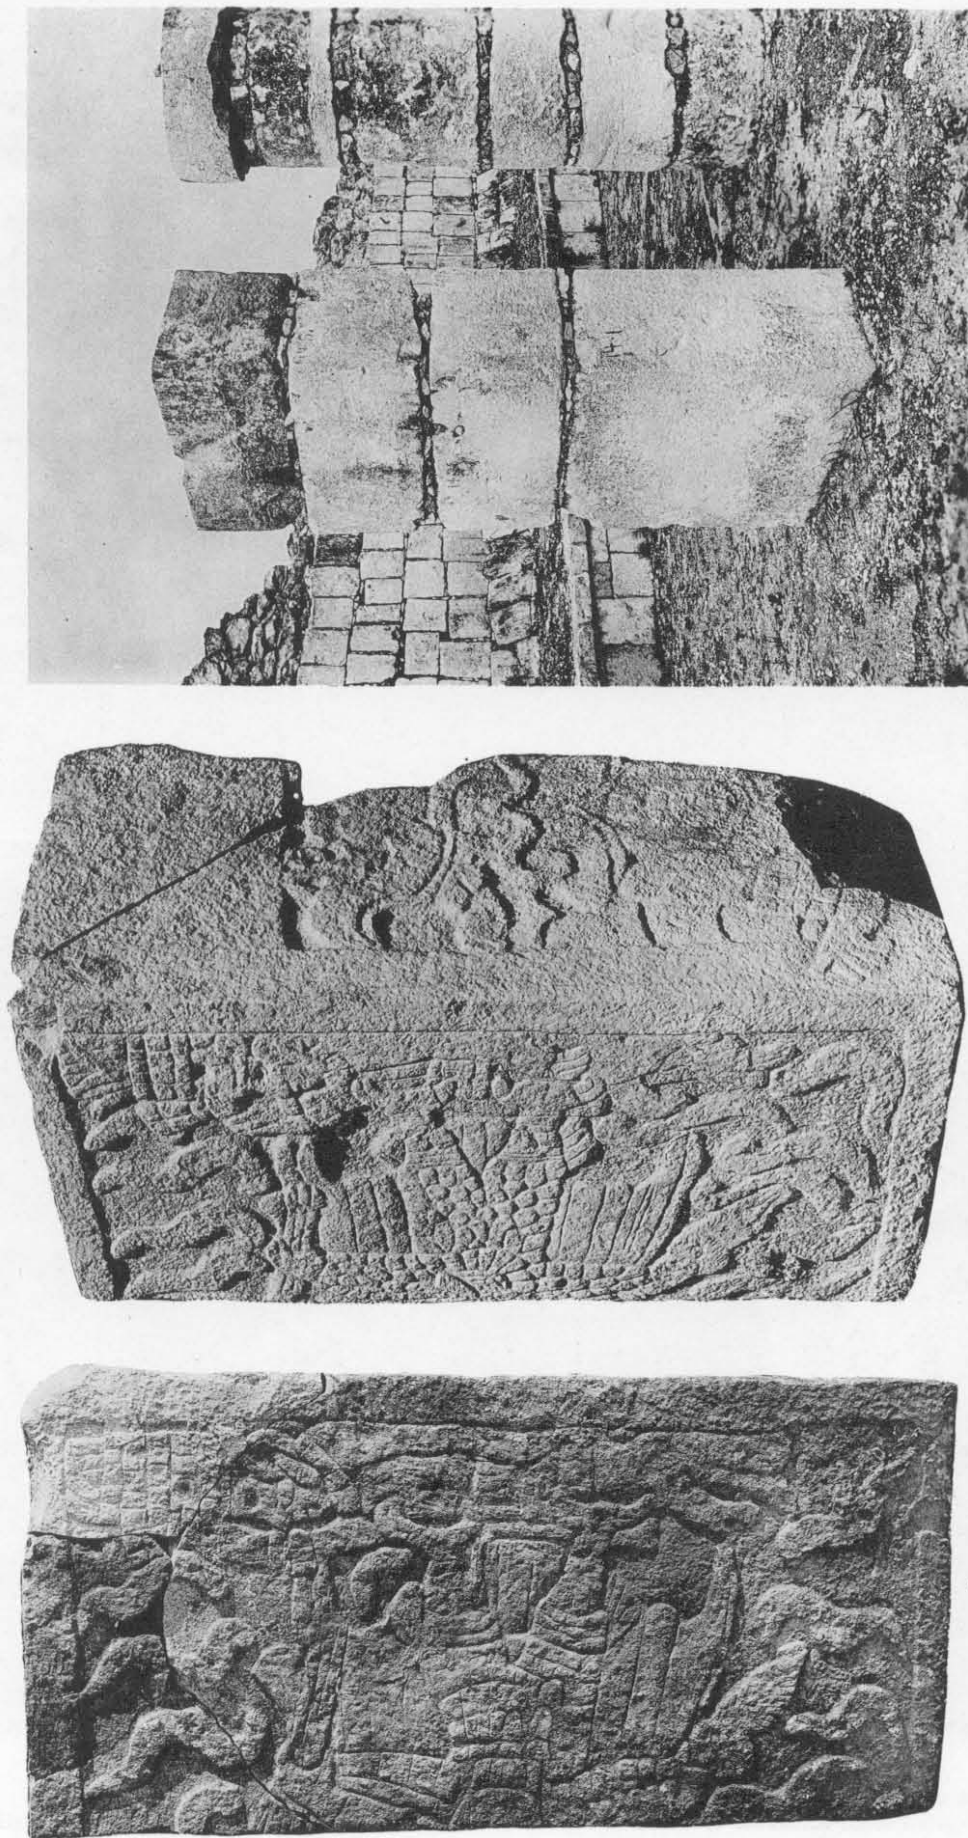
FIG. 12—SCULPTURED STONES, COLUMNS IN GALLERY  
*a, b*: Sculptured stones found at base of east and west balustrades of the stairway. In their original positions these stones were set horizontally.  
*c*: Square and round columns in gallery. Only the round columns have capitals.

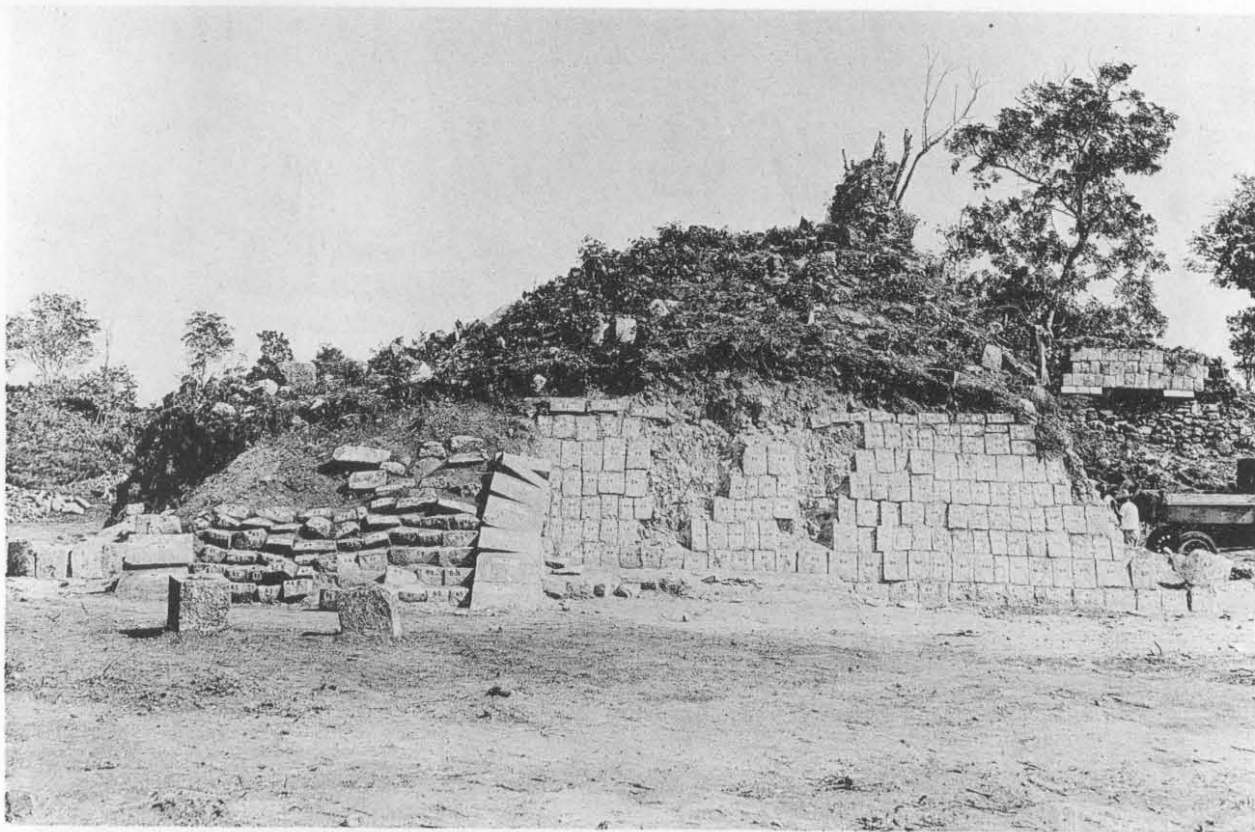
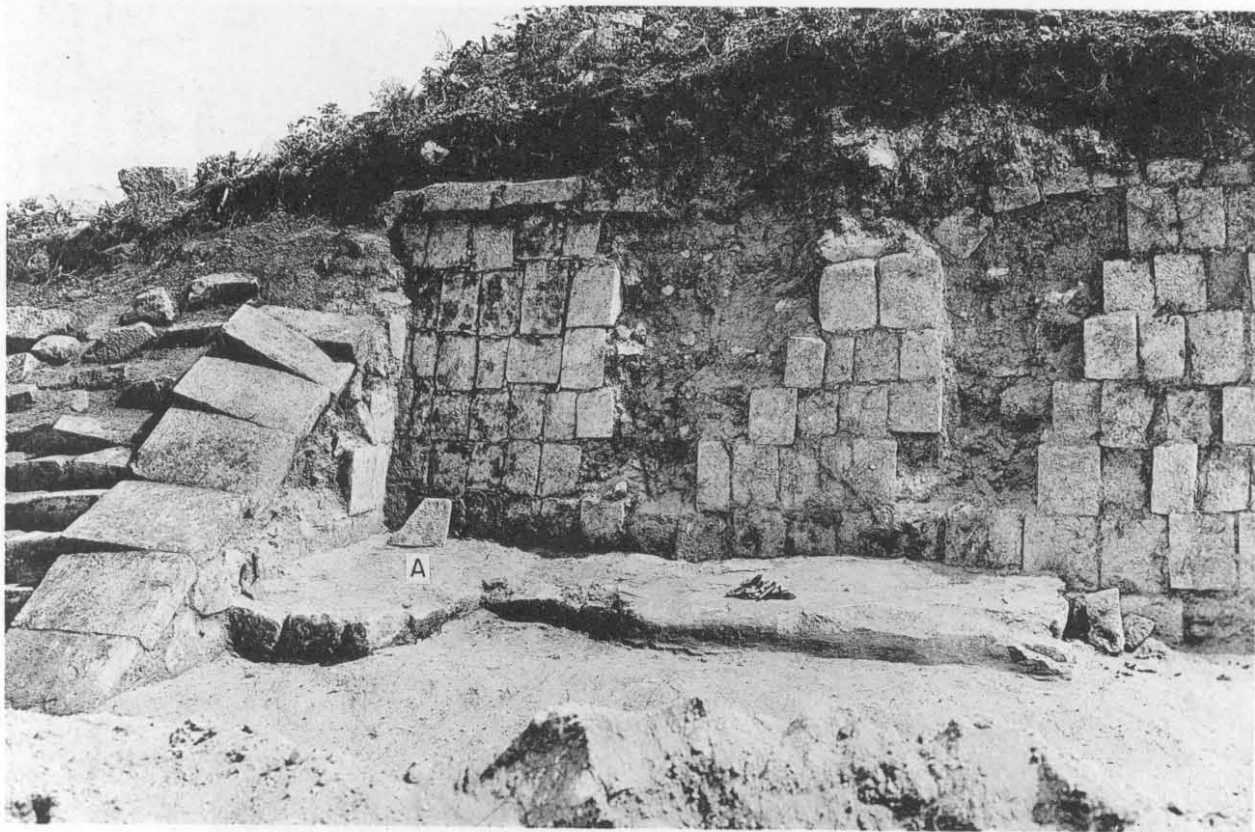
FIG. 13—PLATFORM

*a*: West end and west stairway after excavation.

*b*: Low bench built against south balustrade of west stairway and west end of gallery platform. A, one of the specialized stones of side facing-wall on which capping blocks rest.

Five of the stones comprising the sloping surface of the north balustrade were found, the lower two approximately in their original positions. Seven stones remained on the south balustrade, the lower two *in situ* (fig. 13a). They had been cut with considerable care, were unsculptured, and were covered on the upper surface with several layers of white plaster. The lower side was not worked with a concavity as were those associated with the upper stairway of the Caracol (Ruppert, 1935). The manner of finishing the upper end of the balustrade was not indicated. The facing of the balustrade walls is of fairly well worked stones although they are not uniform in size. Some, on which the capping blocks rested, were cut with one sloping side (fig. 13b,A). The platform-facing extends 10-16 cm. behind the balustrade.

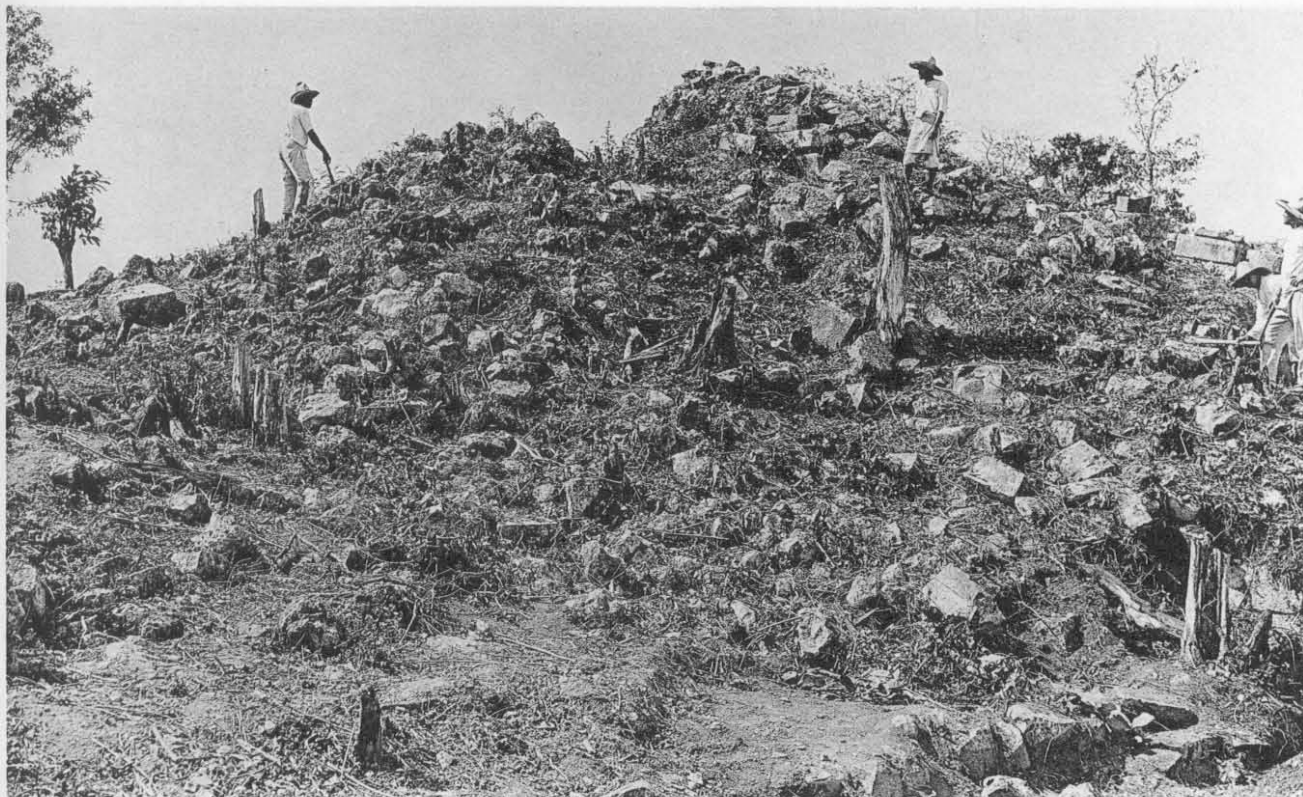
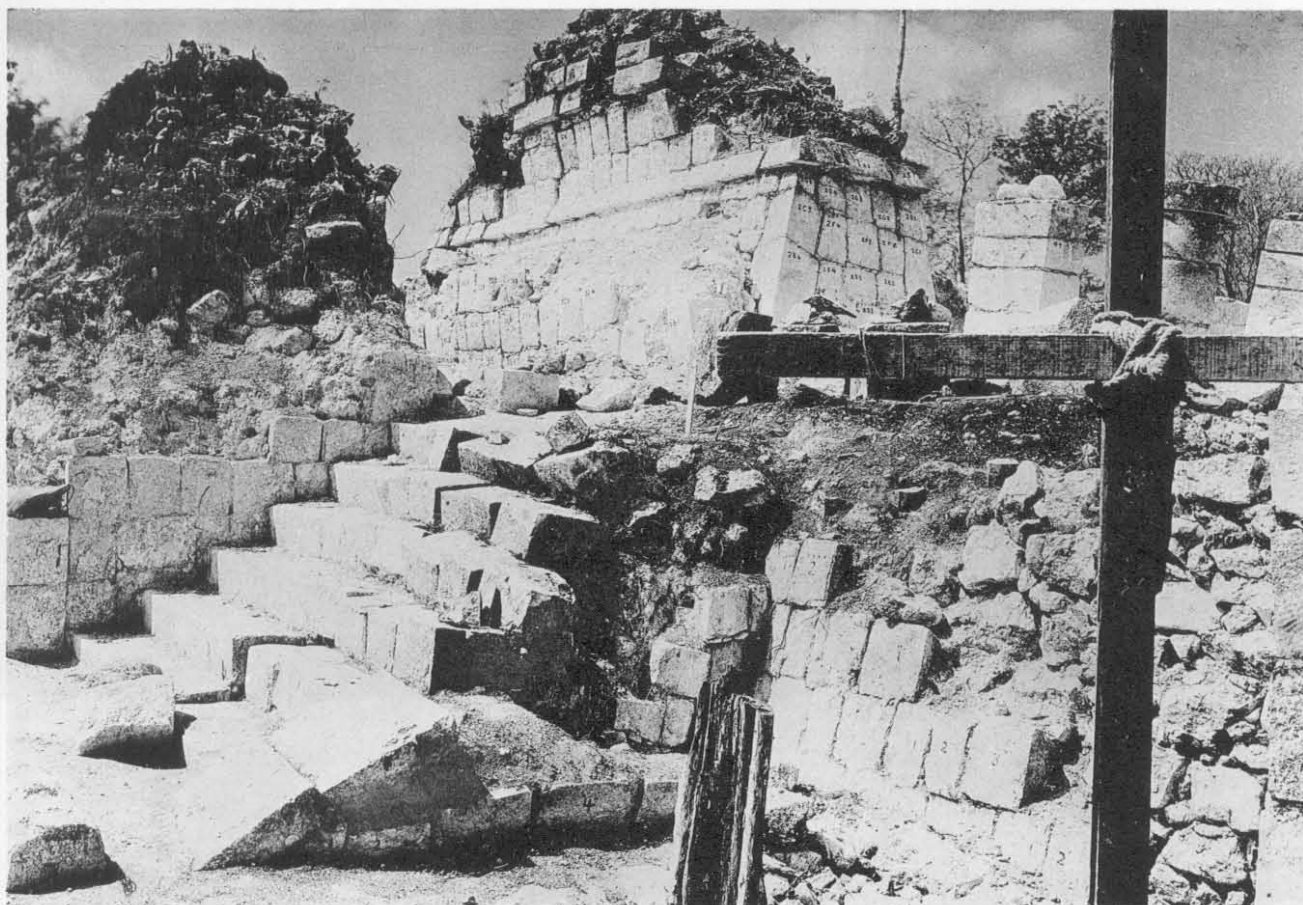
FIG. 14—GALLERY PLATFORM

*a*: East end, view taken in 1932.

*b*: East end showing east stairway and east passageway.

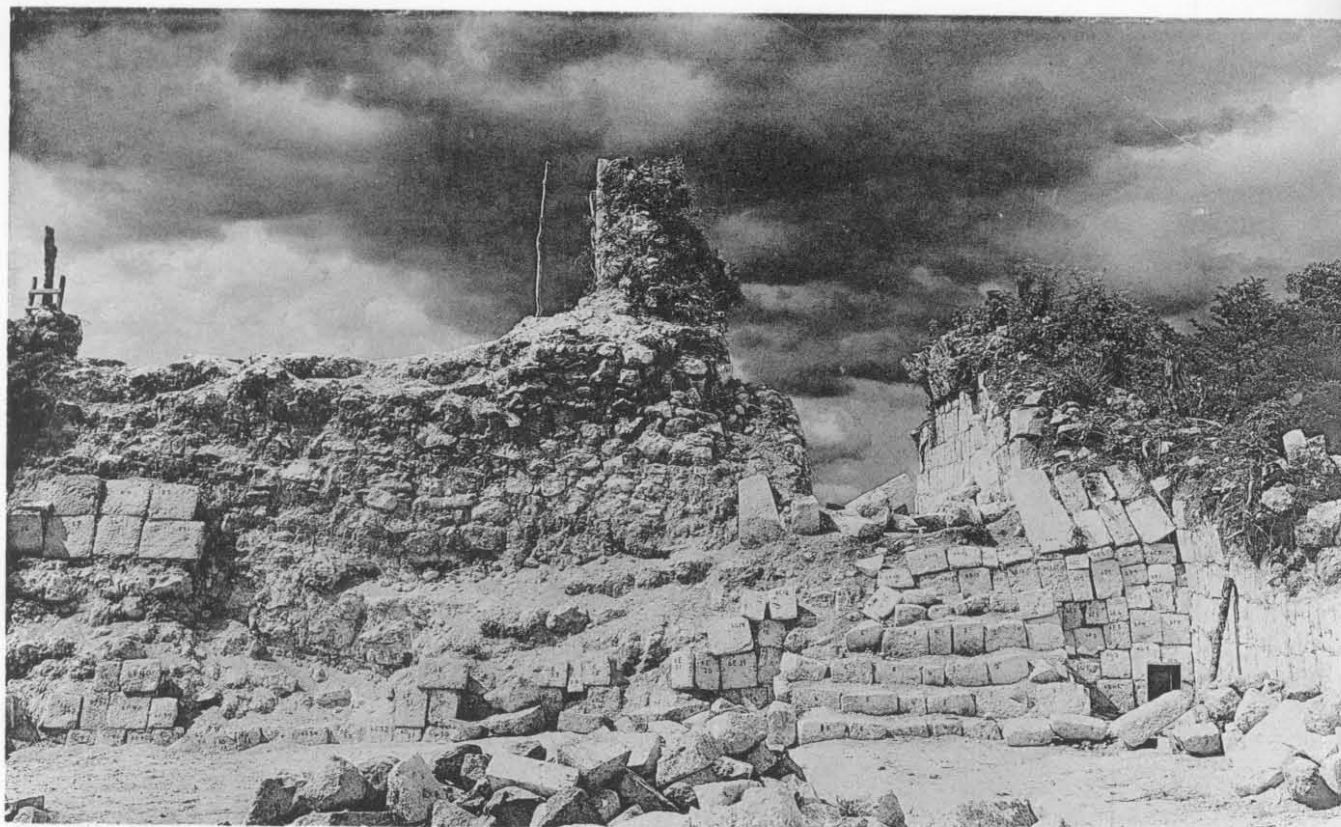
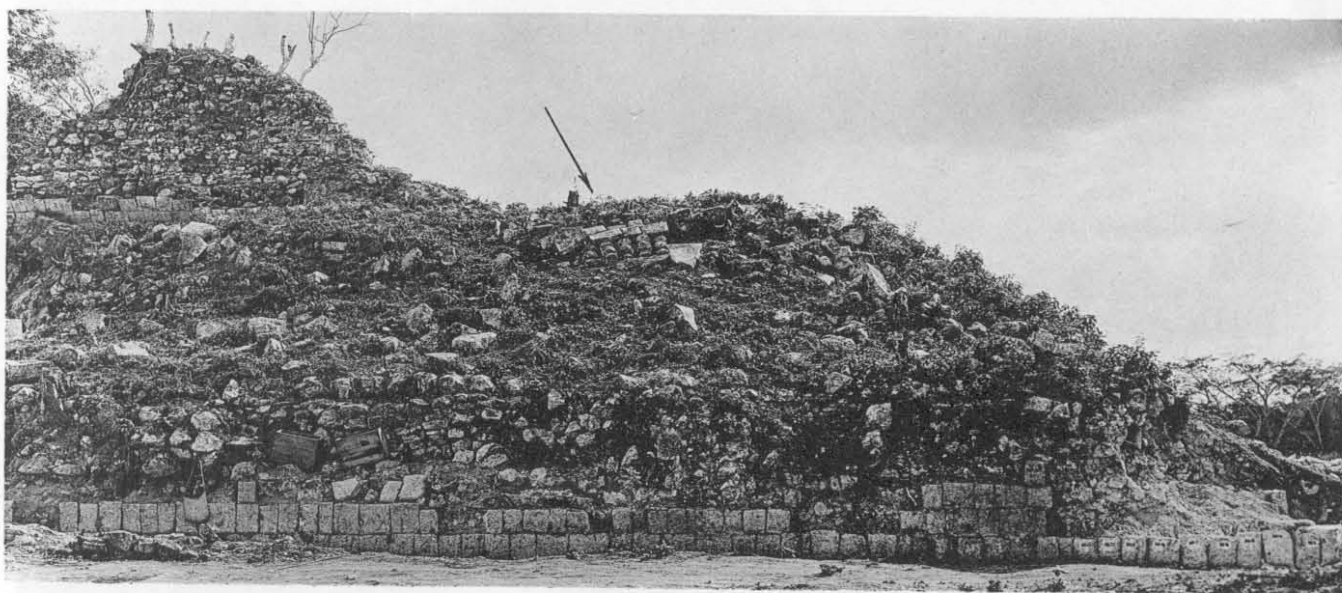
FIG. 15—SOUTH STAIRWAY, EAST PASSAGEWAY, AND WEST END OF GALLERY

a: South stairway and east passageway, view looking north.

b: West end of gallery, view looking south. Arrow indicates group of five spool-shaped stones from façade fallen *en bloc*.
