THE MERCADO  
CHICHEN ITZA, YUCATAN

KARL RUPPERT

Preprinted from Carnegie Institution of Washington Publication 546, pp. 223-260

October 1943

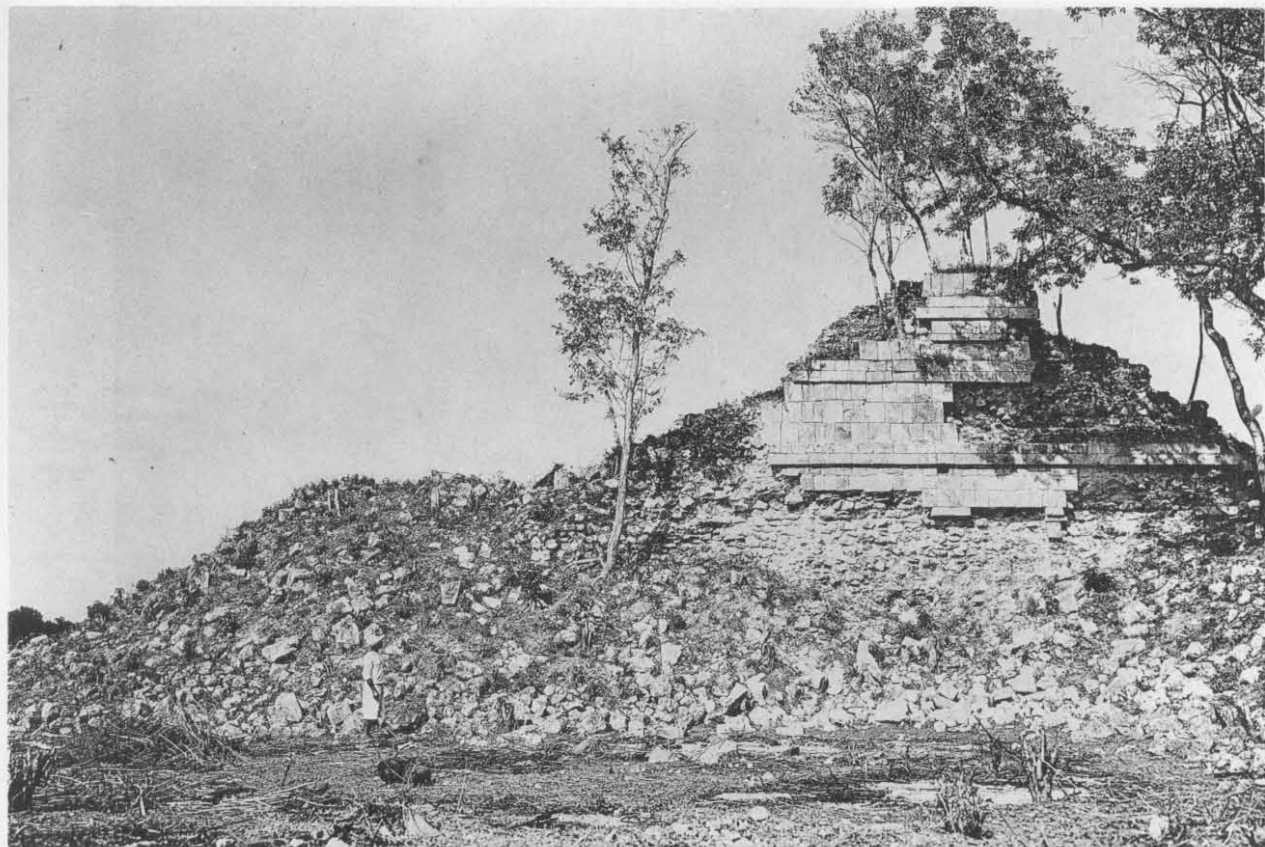
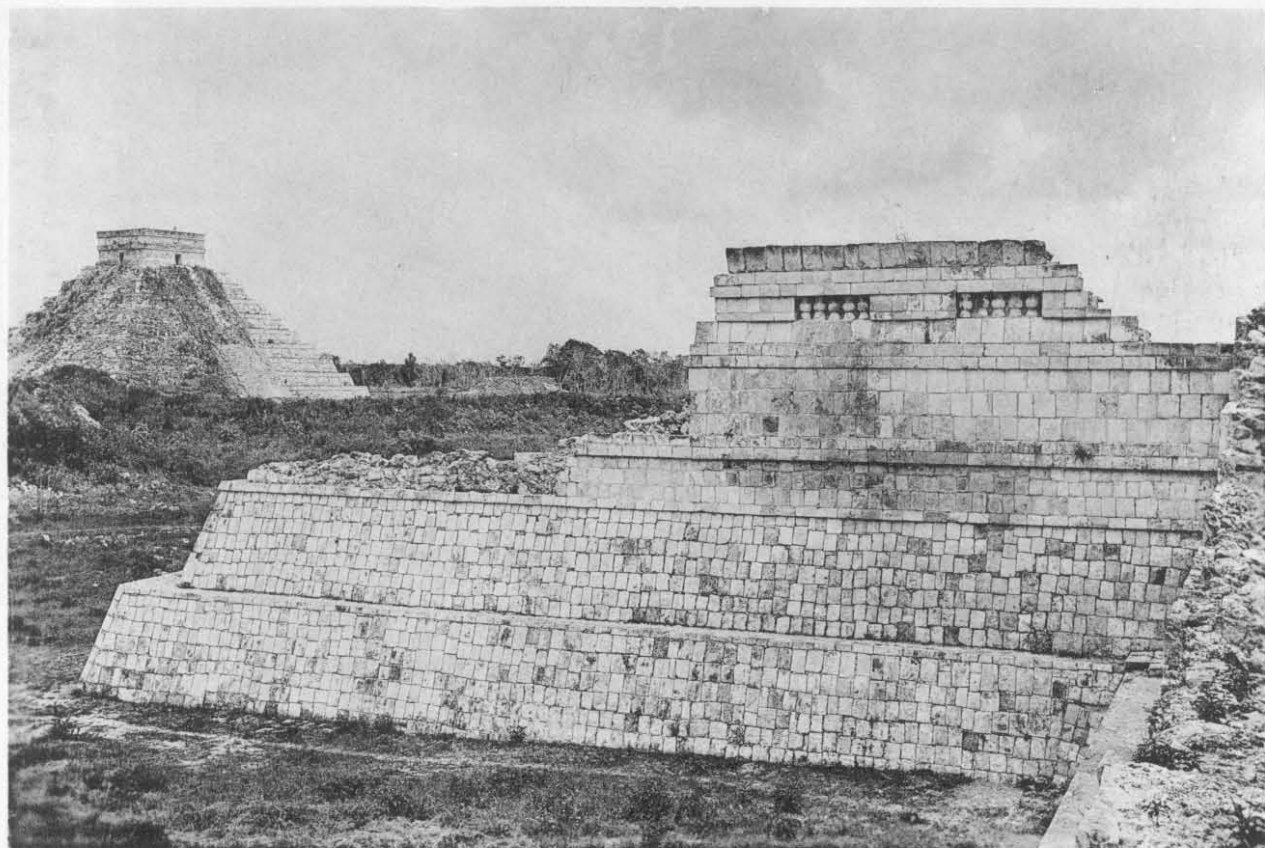
FIG. 16—SOUTH FACADE OF GALLERY, WEST OF PATIO

*a*: Before excavation.

*b*: After repair.

A small section of the south façade of the gallery directly west of the patio was standing (fig. 16a). The lower zone, rising 2 m. at an angle of  $70^{\circ}$ , is the highest battered zone that has so far been reported as associated with a building. The details of the façade are shown in figure 4a. Of special interest is the band, 45 cm. high, of alternate raised metopes and spool panels. The former, about 1.55 m. long, overhang the zone below by 12 cm. In no place was a complete spool panel found *in situ*. However, they were unquestionably composed of five spools, as one panel with five was found on the surface of the north slope of the mound near the west end where it had fallen *en bloc* (figs. 15b and 17c). Other groups of five were encountered during the excavation of the gallery (fig. 17a). These panels had a length of approximately 1.50 m. Each spool measured 45 cm. in height and 23 cm. in diameter and was so set that it was half engaged, its base 3 cm. inward from the top of the battered element on which it rests. The depth of the stone is approximately equal to its height (fig. 17b). The spools were painted blue, and the metope panels and the zones above and below were painted red.

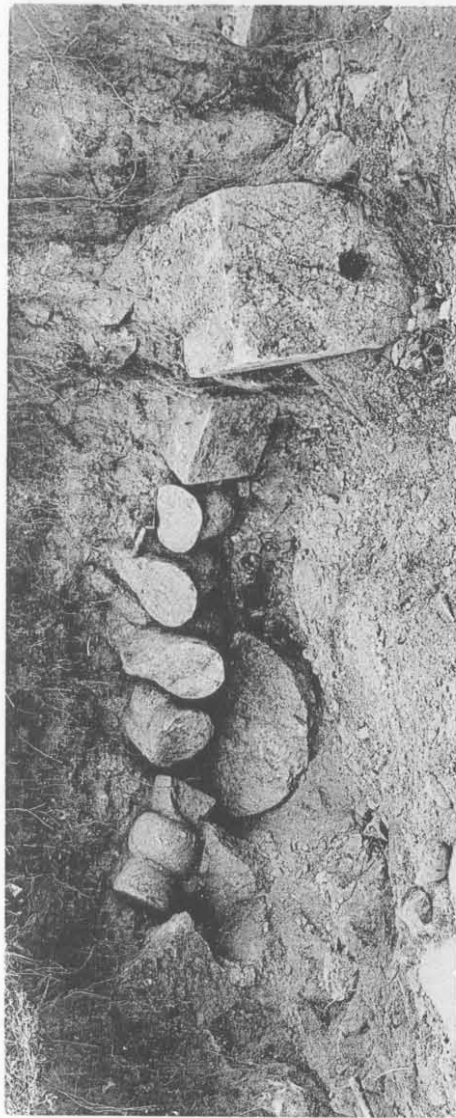
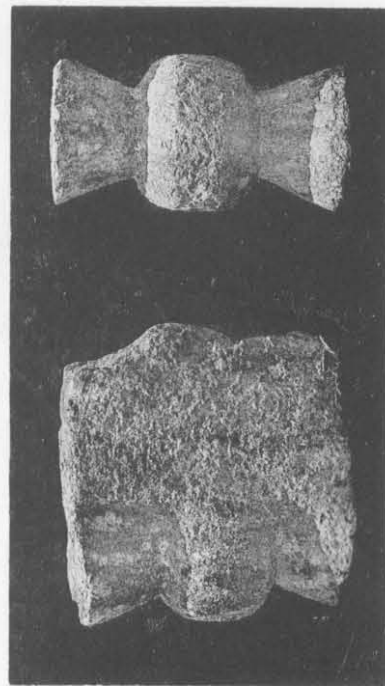
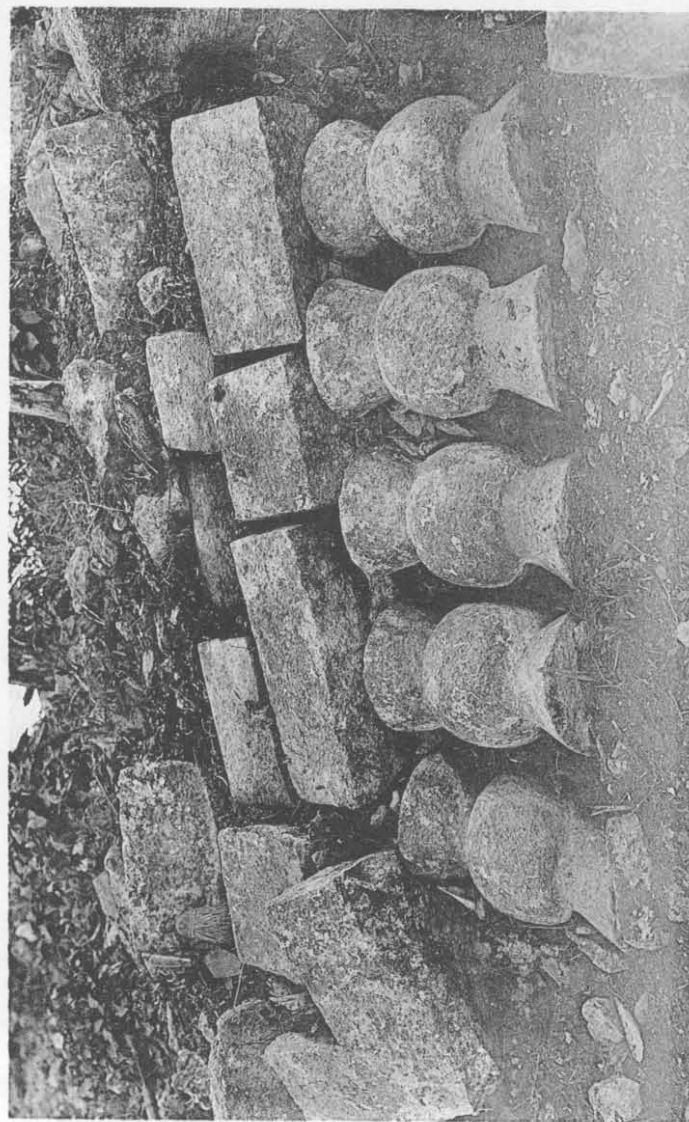
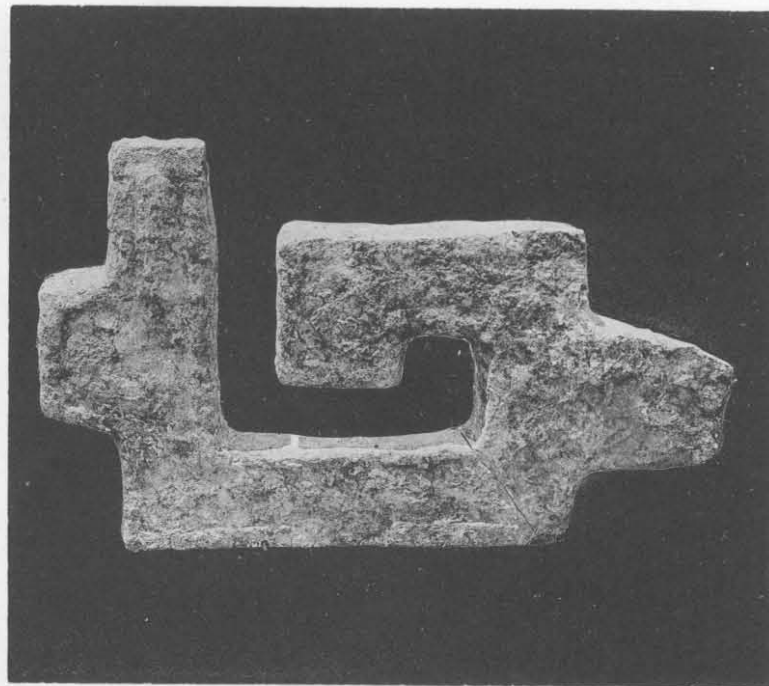
FIG. 17—SPOOLS AND ROOF ORNAMENT  
*a*: Group of five spools from gallery facade, found during excavation.  
*b*: Side and front views of a spool (height 45 cm.).  
*c*: Group of five spools found on surface where they had fallen with collapse of facade.  
*d*: Roof ornament from Mercado (height 75 cm.).

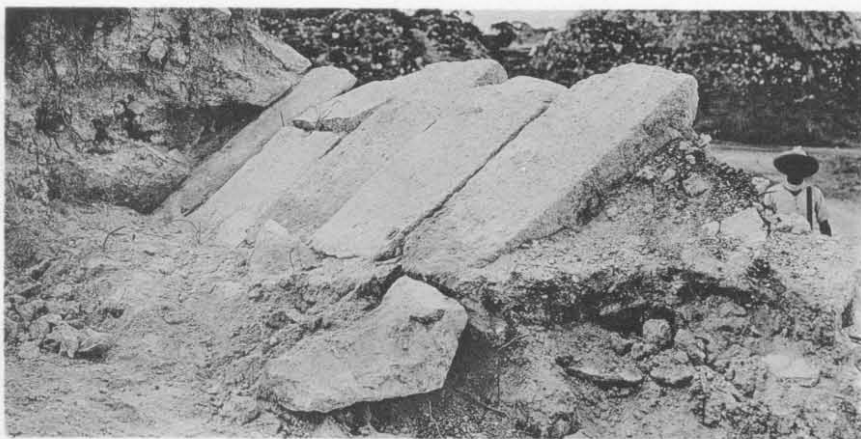
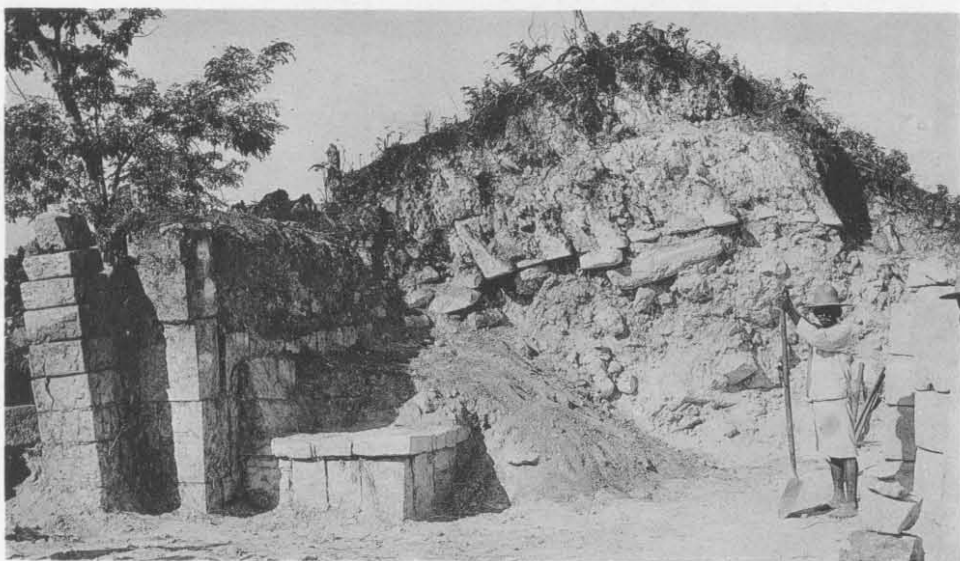
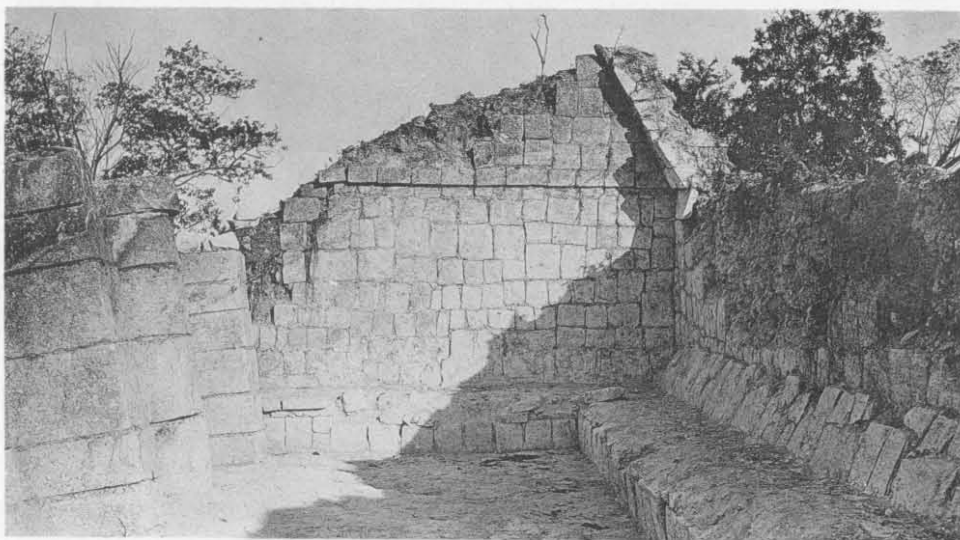
FIG. 18—GALLERY

- a*: West half of gallery showing capstones uncovered during excavations.  
*b*: West half of gallery showing sculptured pilaster, bench, and collapsed vault.  
*c*: Gallery interior, east end.

At the top of the vault was a 12-cm. vertical band on which rested the capstones. Although none of the band stones were found *in situ*, some, uncovered in the debris at the west end and in their original order, were associated with those of the vault. Excavation showed that the outer (north) half of the vault fell first. With the decay of the timbers spanning the intercolumnar spaces, the portion of the vault they supported fell into the gallery. Following this the south half collapsed upon the north (fig. 18b).

The capstones which rested on the band are all large slabs carefully worked and nicely finished on the under side. Those in line with Column 21 are shown as they fell with the collapse of the vault (fig. 24b). They were found in the debris 1.50 m. above the floor (fig. 18a).

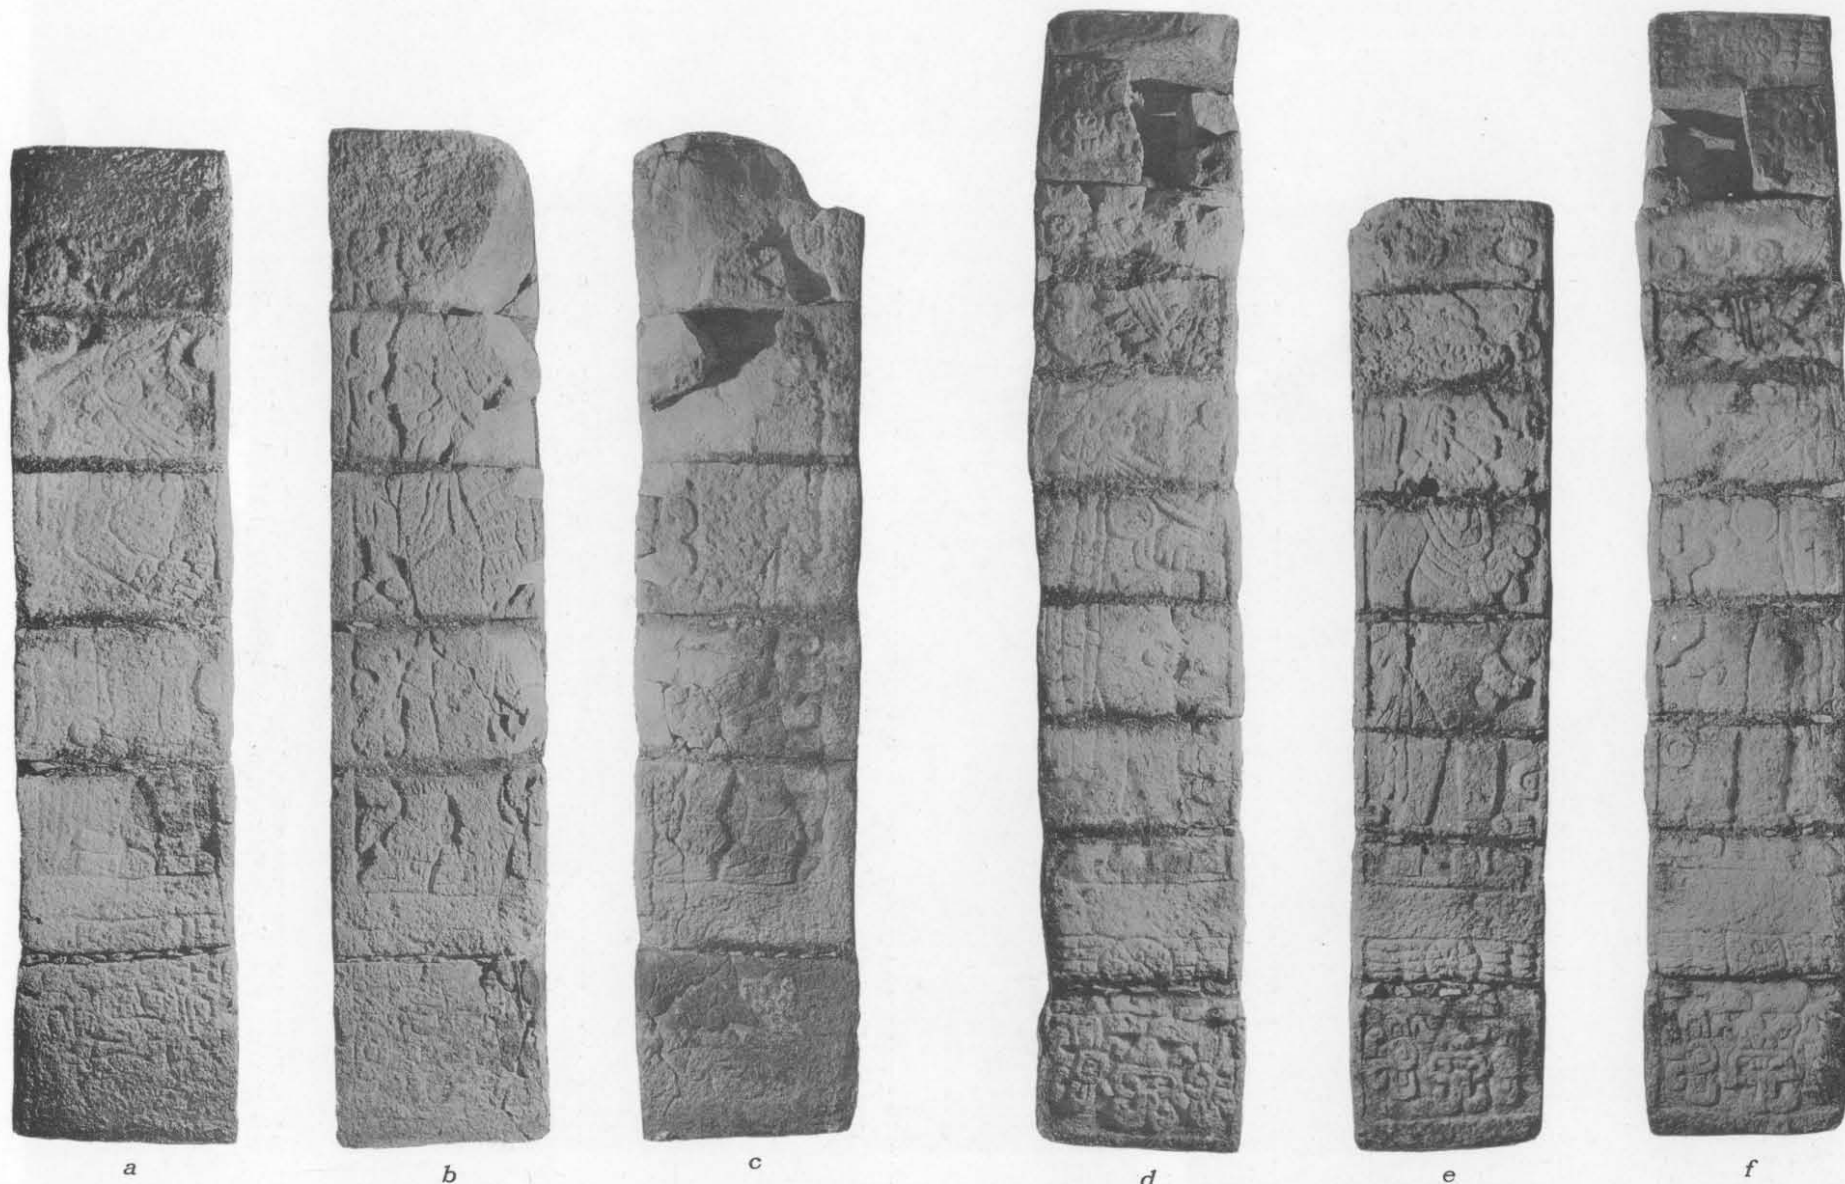
FIG. 19—SCULPTURED PILASTERS OF DOORWAY LEADING FROM GALLERY TO PATIO

*a-c:* North, west, and south faces of east pilaster.

*d-f:* South, east, and north faces of west pilaster.

*Pilasters.* Built against each jamb is a pilaster, its face sculptured in low relief depicting mask panels and human figures. Some of the component stones are much weathered and portions are broken and chipped. The sculpture lacks uniformity; certain parts are carefully executed and others are portrayed by only incised lines. The faces of the pilasters are illustrated in figures 19 and 20.

*North side* (figs. 19a, 20a). Figure wears serpent headdress from which rises an elaborated plume or noseplug. Man's face appears in open jaws of serpent. Ornaments: ear disk, long bar-bead for nose, wristlets, and bead necklace. Serpent body or a long cape hangs down behind figure to level of feet. Body partially nude. Sandals, and possibly garters, indicated.

*West side* (figs. 19b, 20b). Chipped and broken along top and south edge. Type of headdress can not be made out. Ornaments: long bar-bead in nose, ear ornament is bar from which hangs pendant and two feathers. Body nude except for beaded breastplate, padded left arm, garters, and sandals. Atlatl in upraised right hand, curved stick in left hand.

*South side* (figs. 19c, 20c). Much destroyed. Left arm probably padded. Garters and sandals worn.

*South side* (figs. 19d, 20d). Figure wears serpent headdress ornamented with elaborated plume or noseplug. Serpent body draped down back. Ornaments: round earplug, bar-bead in nose. Save for headdress, disk breastplate, wristlets, and sandals, the figure is nude.

*East side* (figs. 19e, 20e). Figure wears turban-like headdress ornamented with a row of rosettes. Elaborate ear decoration, and nose pierced by long bar-bead. Figure is nude except for necklace or breastplate, wristlets, and sandals. A number of spear shafts and a curved stick held in right hand. An atlatl is probably held in the left hand.

*North side* (figs. 19f, 20f). Figure wears serpent headdress, from which rises a short plume, perhaps a noseplug. Serpent body or cape hanging down

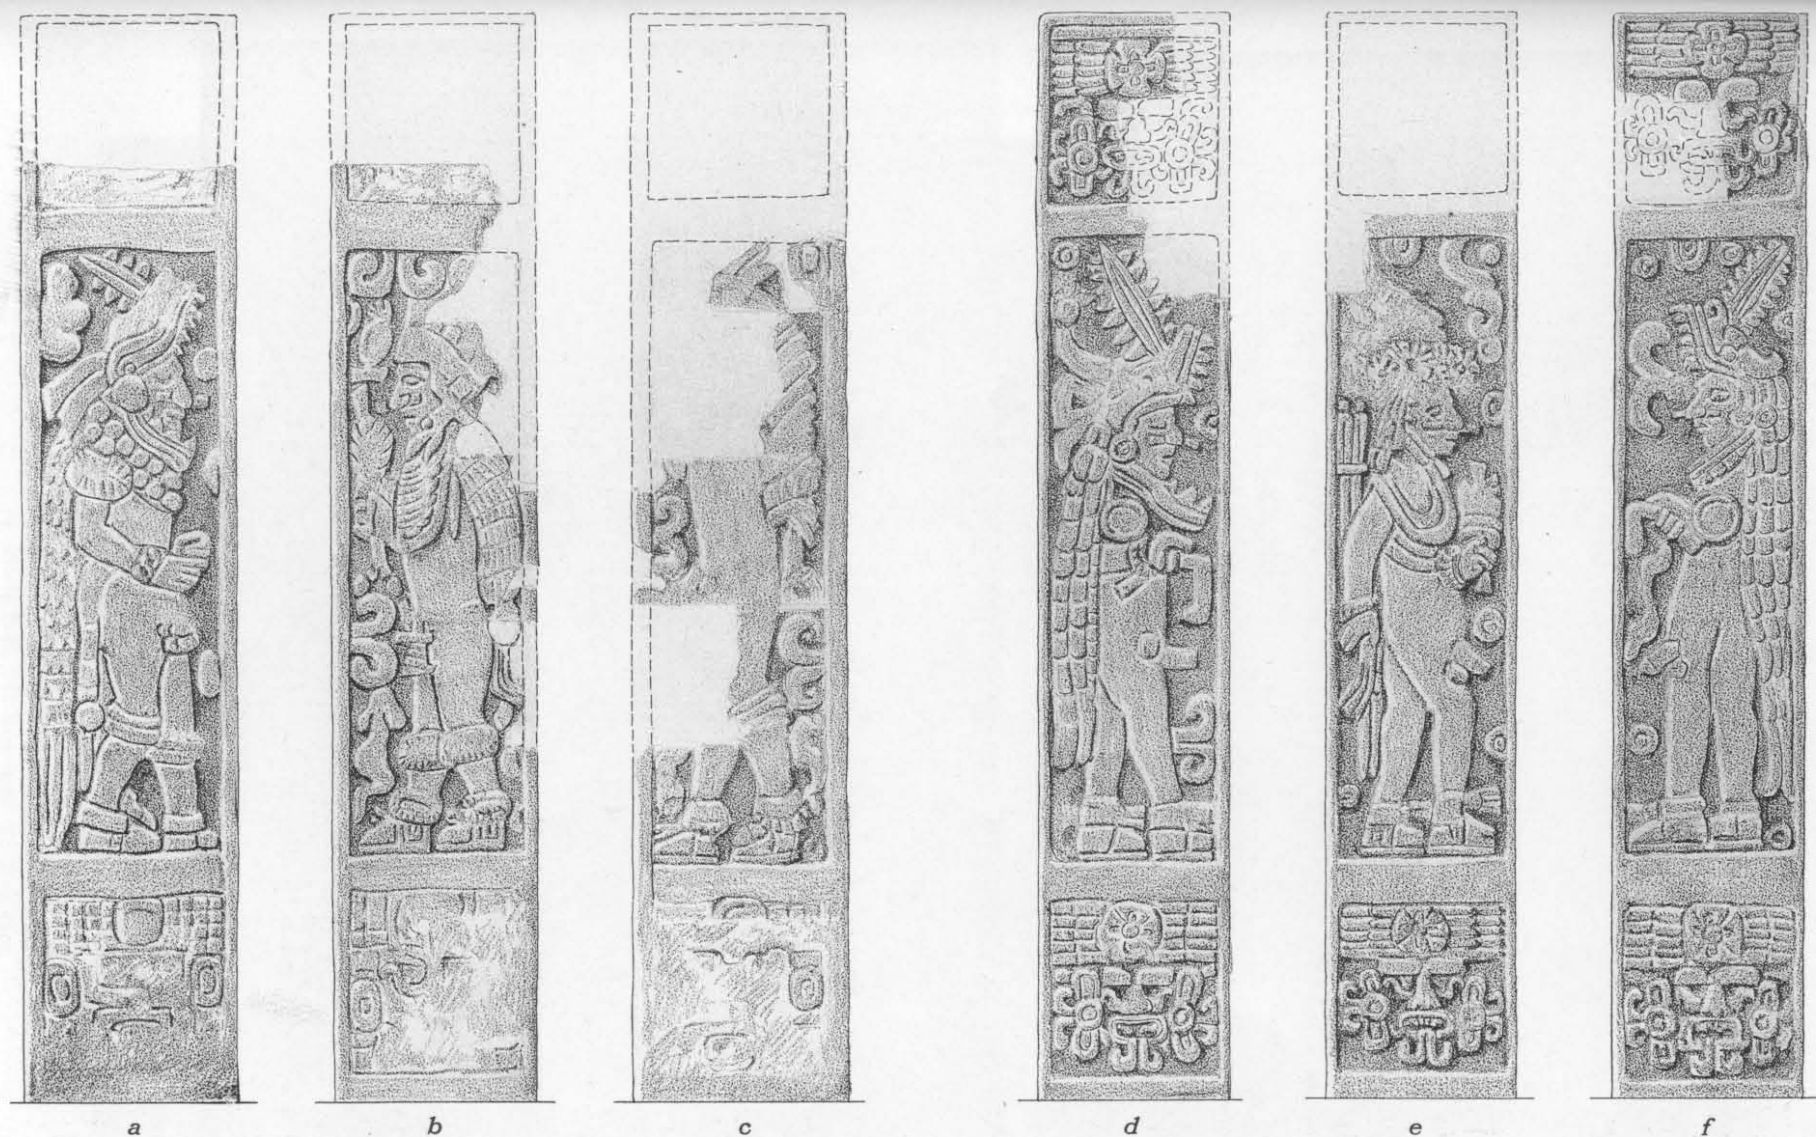
FIG. 20—DRAWING OF SCULPTURED PILASTERS OF DOORWAY  
LEADING FROM GALLERY TO PATIO  
*a-c*: North, west, and south faces of east pilaster.  
*d-f*: South, east, and north faces of west pilaster.

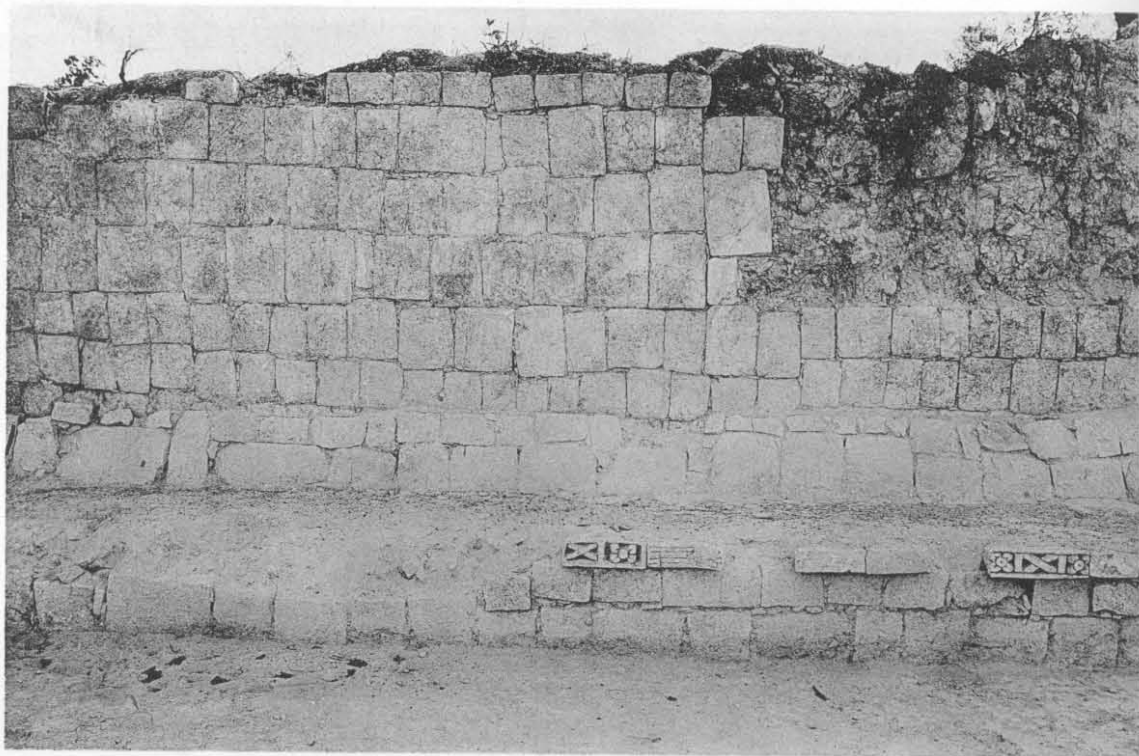
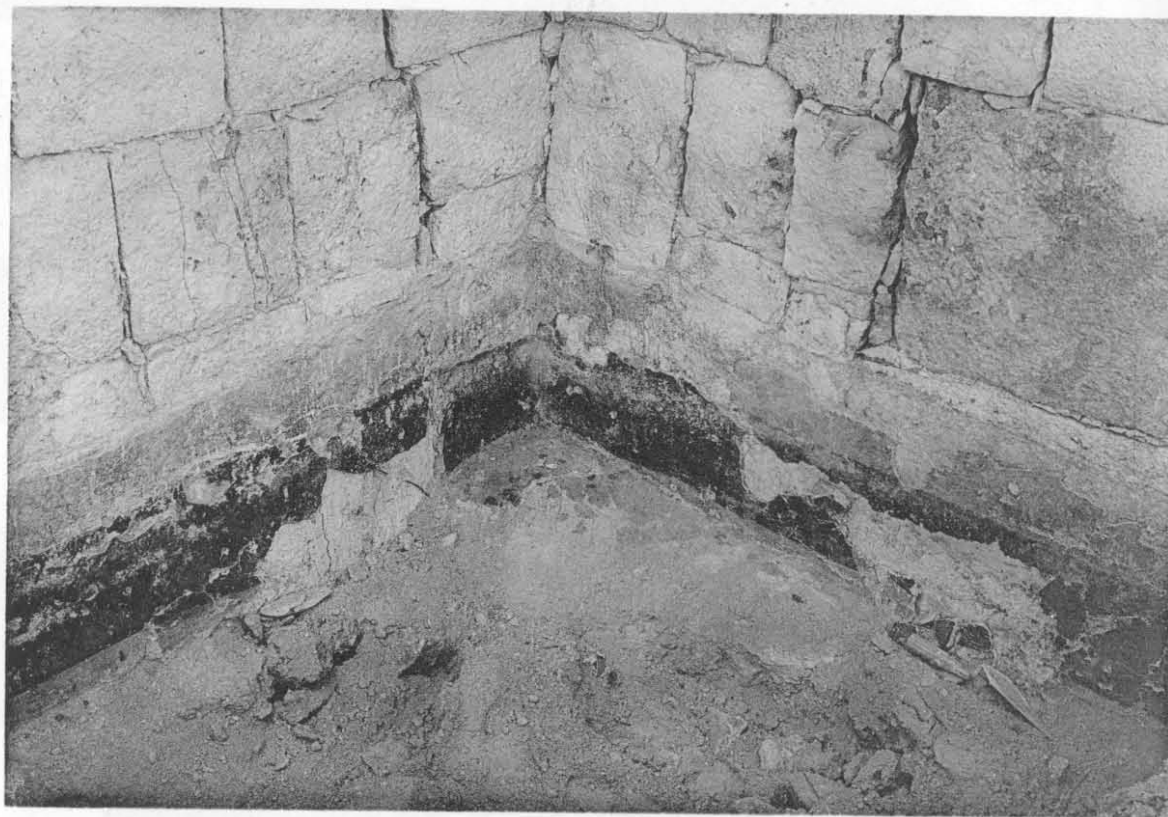
FIG. 21—SOUTH INTERIOR WALL AND CORNER OF GALLERY

*a*: South interior wall of gallery showing occasional sculptured stone used in cornice of bench.  
*b*: Southeast interior corner of gallery. Portion of step and painted bands on the wall.

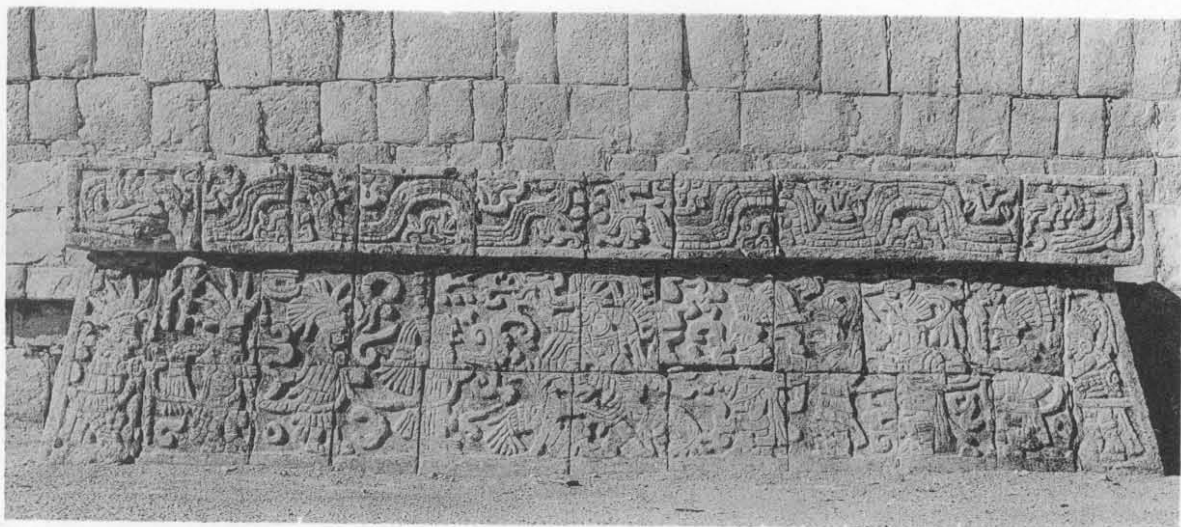
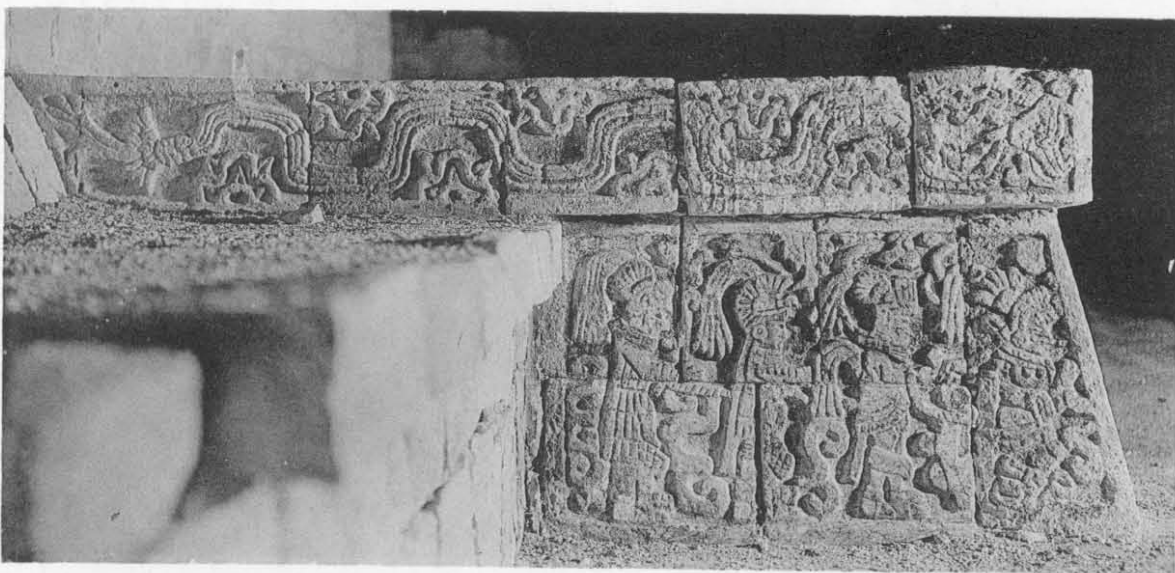
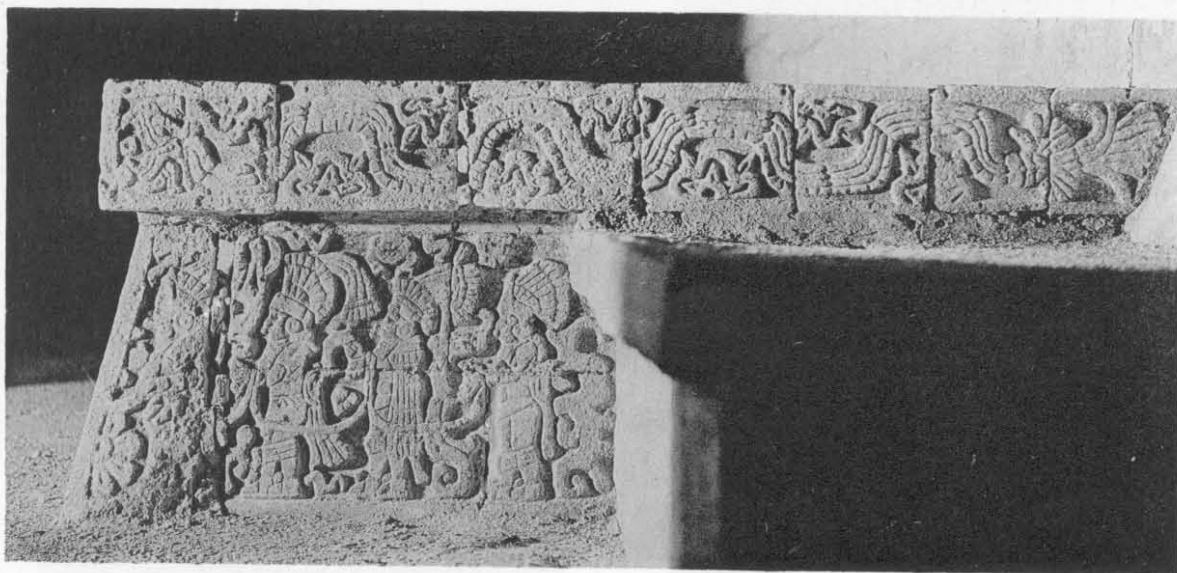
FIG. 22—SCULPTURED DAIS IN GALLERY  
*a*: North face. *b*: East face. *c*: West face.

*Sculptured Dais.* To the east of the doorway leading into the patio is a sculptured dais. It is built against the gallery wall and is contemporaneous with the bench. The face of the dais rises with a batter to a vertical cornice. On the sides the cornice extends back across the bench to the wall. The cornice stone at the northeast corner had been dislodged and was found on the floor.

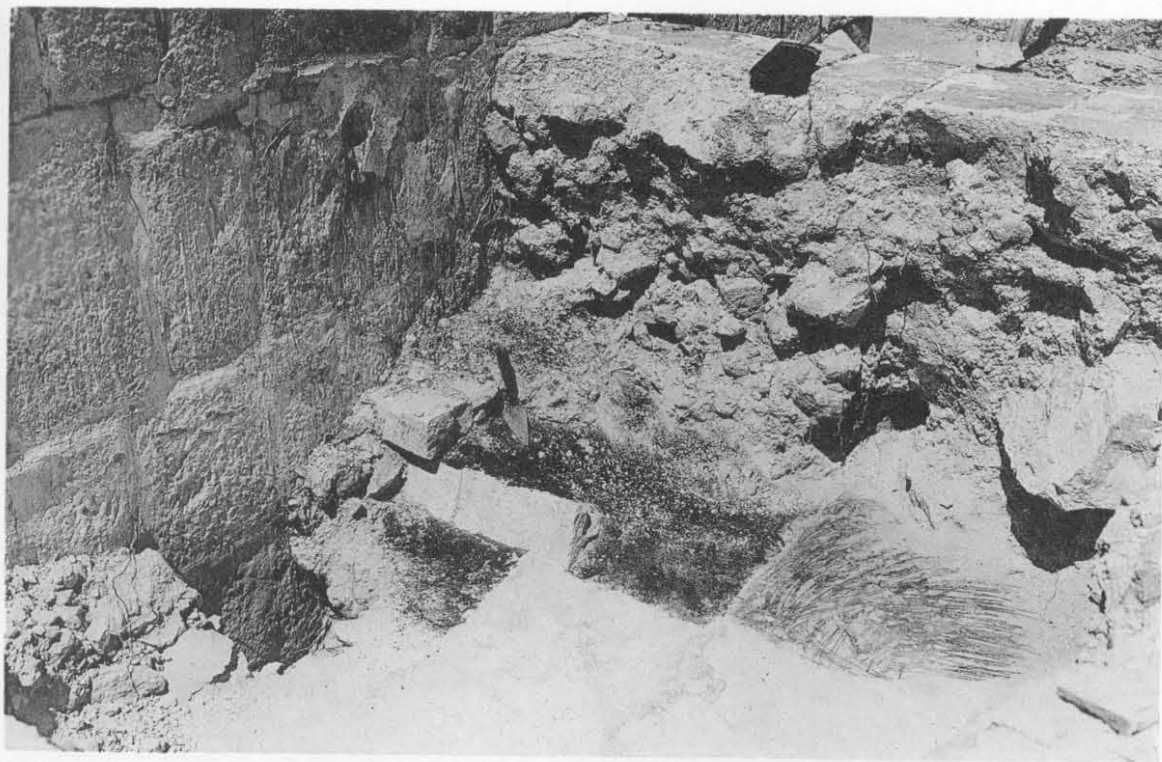
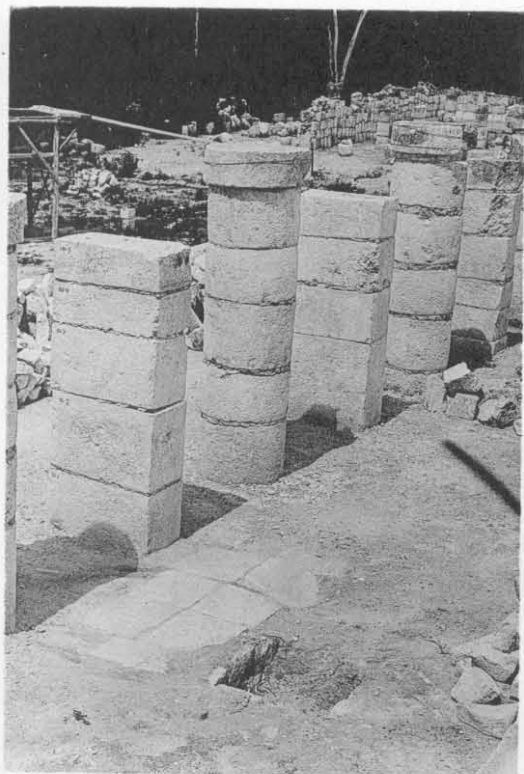
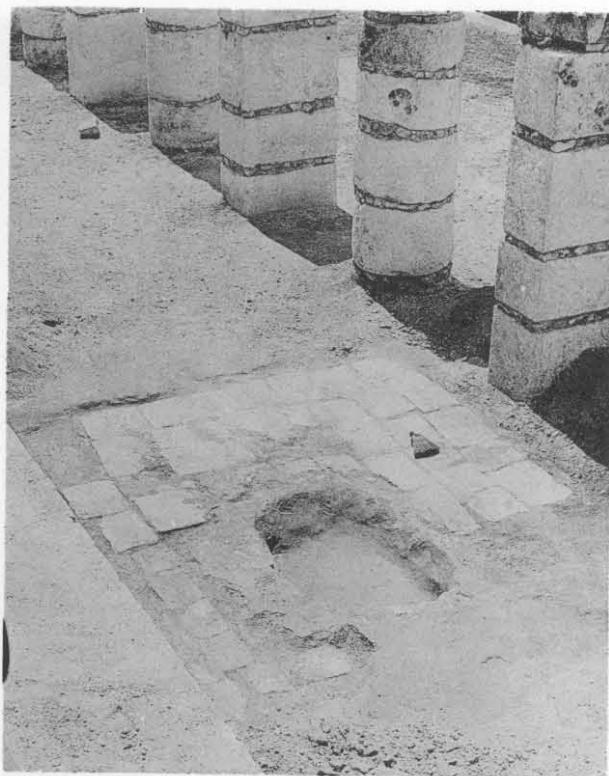
FIG. 26—SCULPTURED DAIS AND FIREBOX  
*a*: Portions of earlier dais found within sculptured one.  
*b*: Firebox in floor of gallery south of Columns 9 and 10.  
*c*: Firebox in floor of gallery south of Columns 28 and 29.

*Fireboxes.* Between Columns 9 and 10, and 1.25 m. to the south of the latter is a masonry-lined firebox set in the floor. The sides, of flat stones set on edge, are vertical except that on the east which rises with a slight angle (fig. 26b). The depression was filled with ashes and the facing stones are calcined. Ashes were also found on the floor to the east of the depression. The floor north of the firebox and to within 12 cm. of the column is of flagstones.

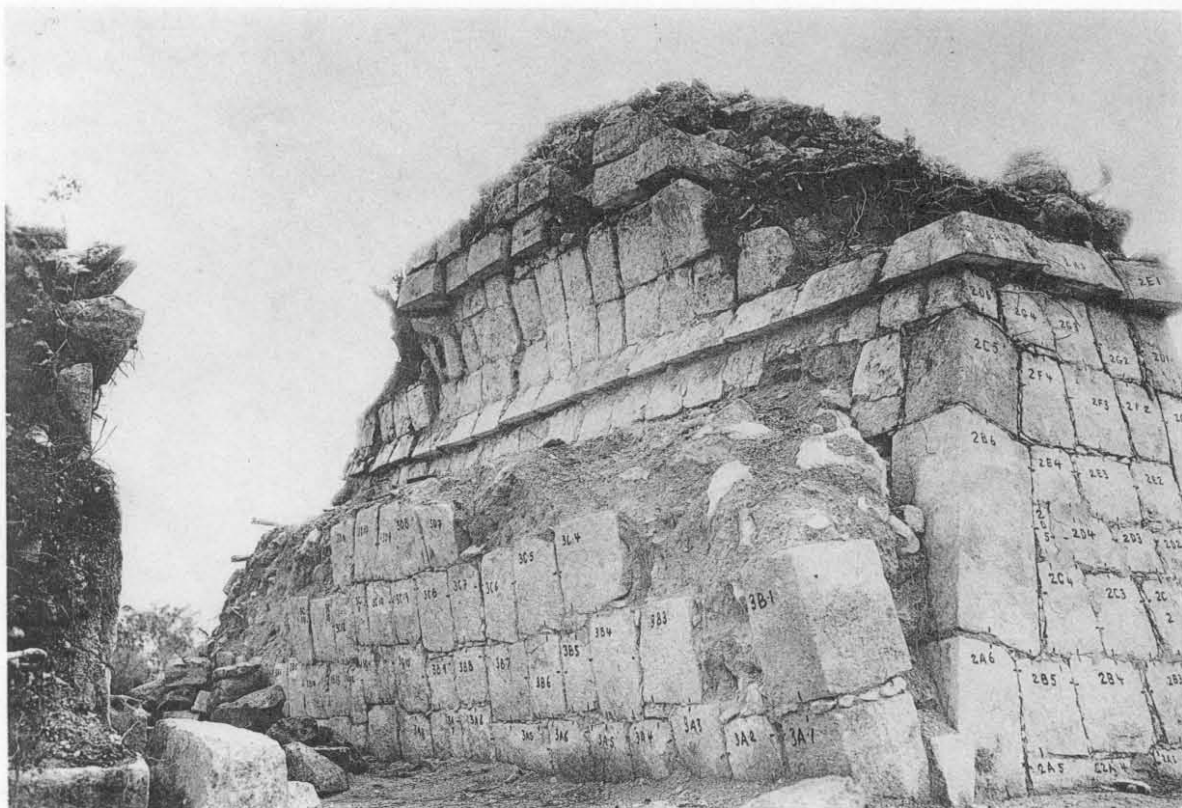
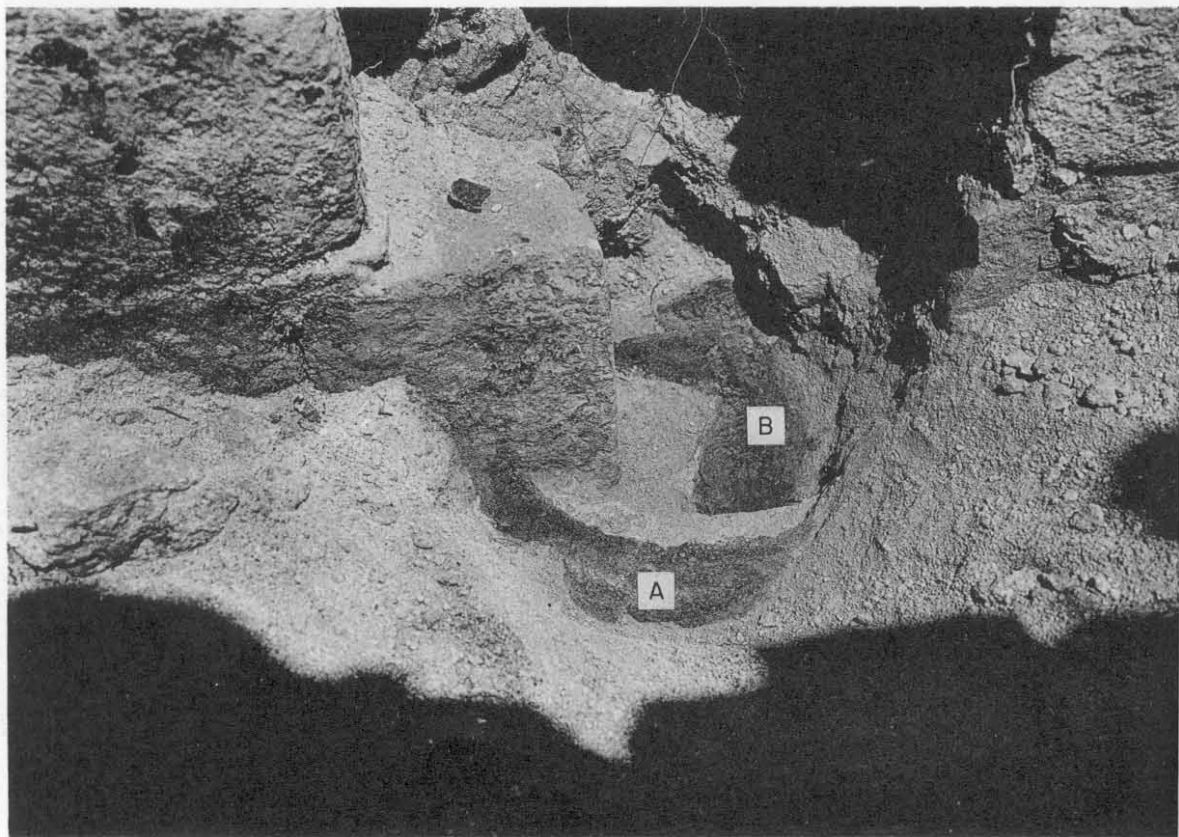
FIG. 27—WEST WALL AND FLOOR OF EAST PASSAGEWAY  
*a*: West wall of east passageway built against east end of gallery.  
*b*: West wall and floor (A) of east passageway. B, floor associated with gallery platform.

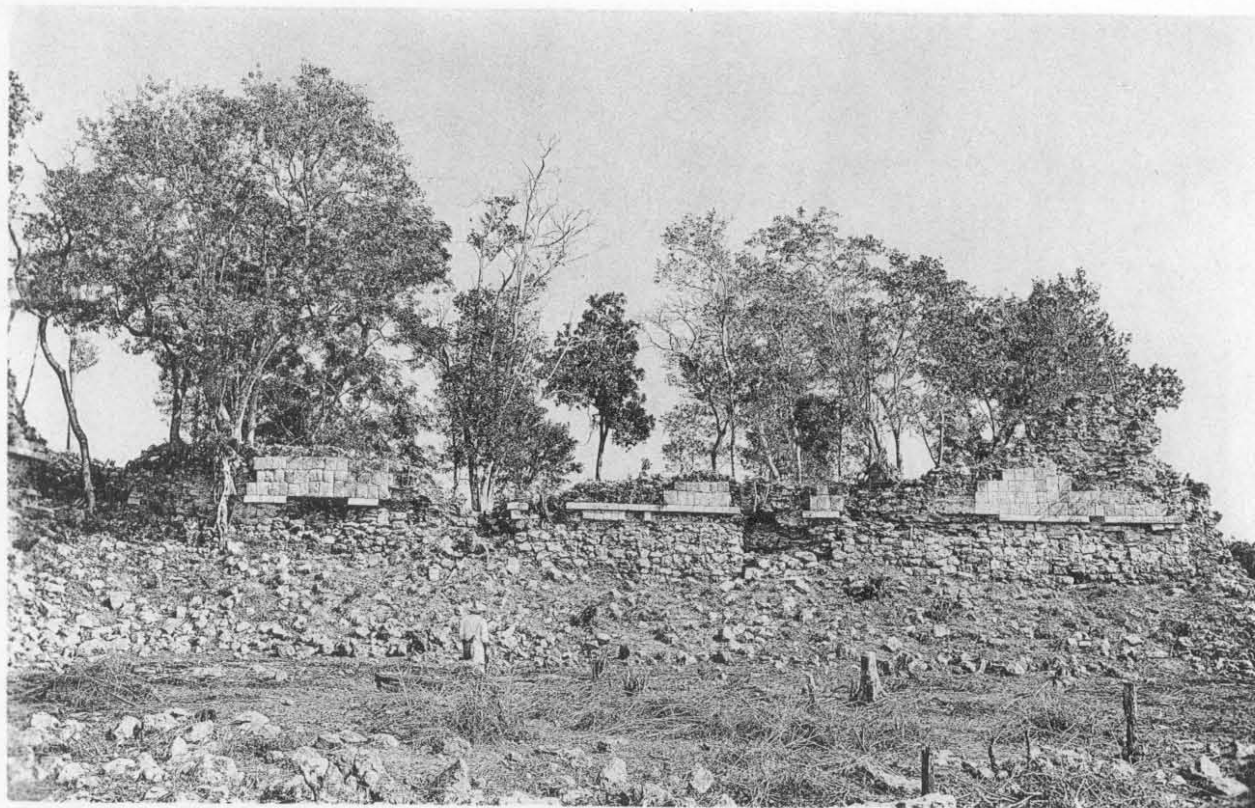
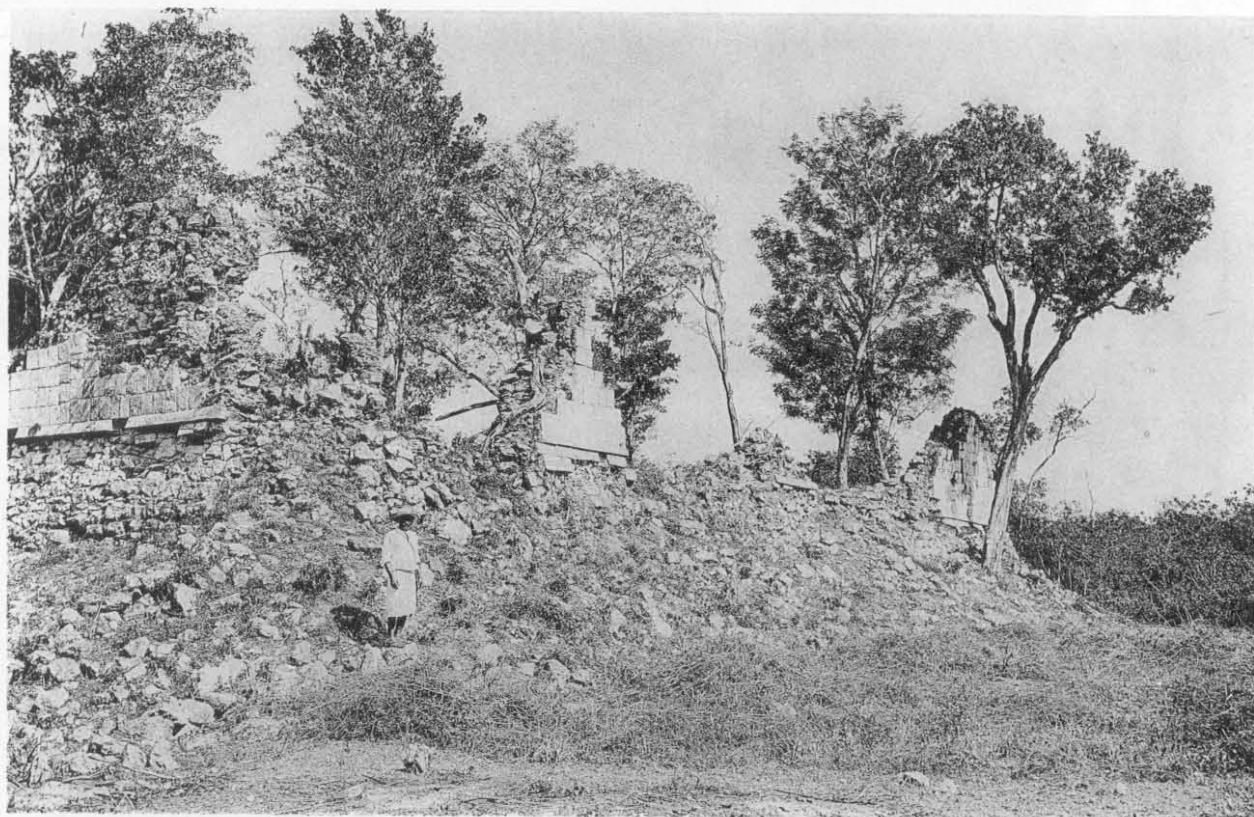
FIG. 28—PATIO EXTERIOR  
*a*: West exterior before excavation.  
*b*: South exterior.

The exterior face of the patio wall rose with a batter similar to that of the gallery. On this rests a 20-cm. apron molding followed by a plain vertical zone; sections of the latter were found rising to a height of 2.30 m. (fig. 28b). Originally this zone probably measured 4.85 m., bringing the façade to the same height as that of the gallery (7.05 m.). It presumably was not finished with a cornice as no stones of this type were found in the debris when the west side was excavated.
