THE MERCADO  
CHICHEN ITZA, YUCATAN

KARL RUPPERT

Preprinted from Carnegie Institution of Washington Publication 546, pp. 223-260

October 1943

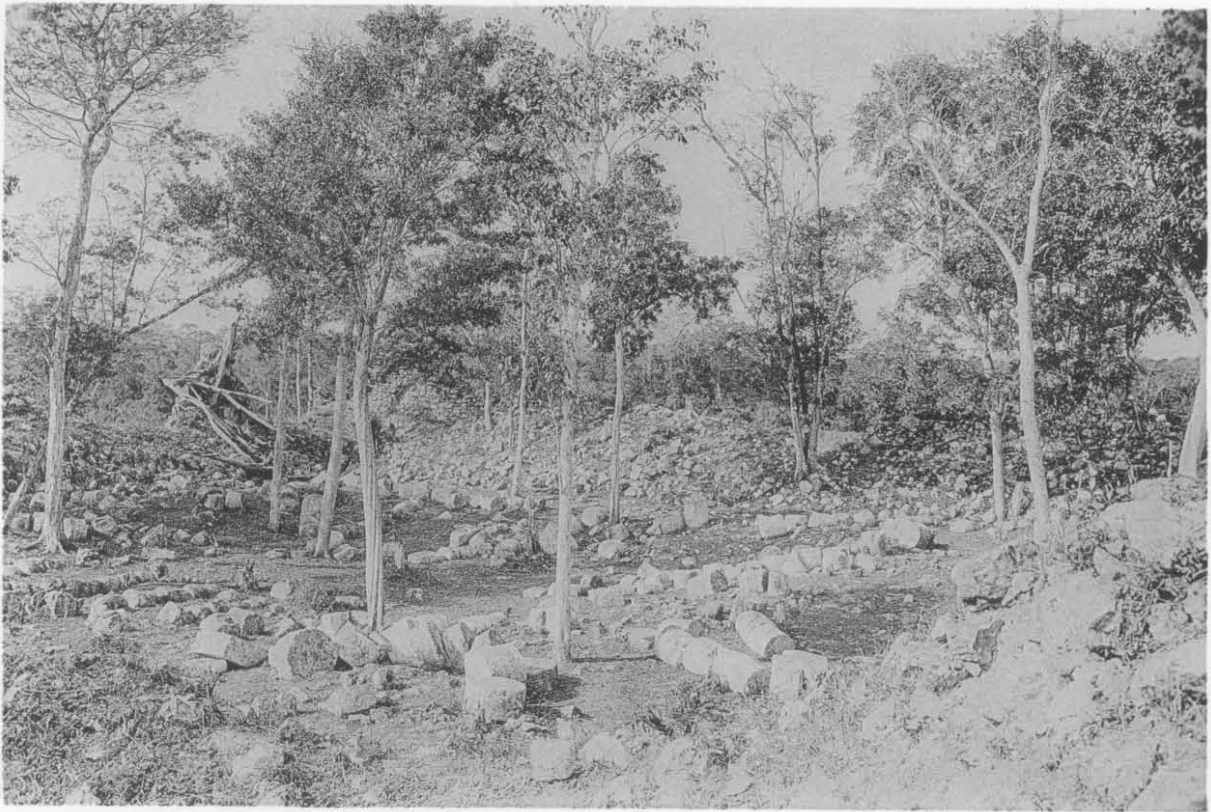
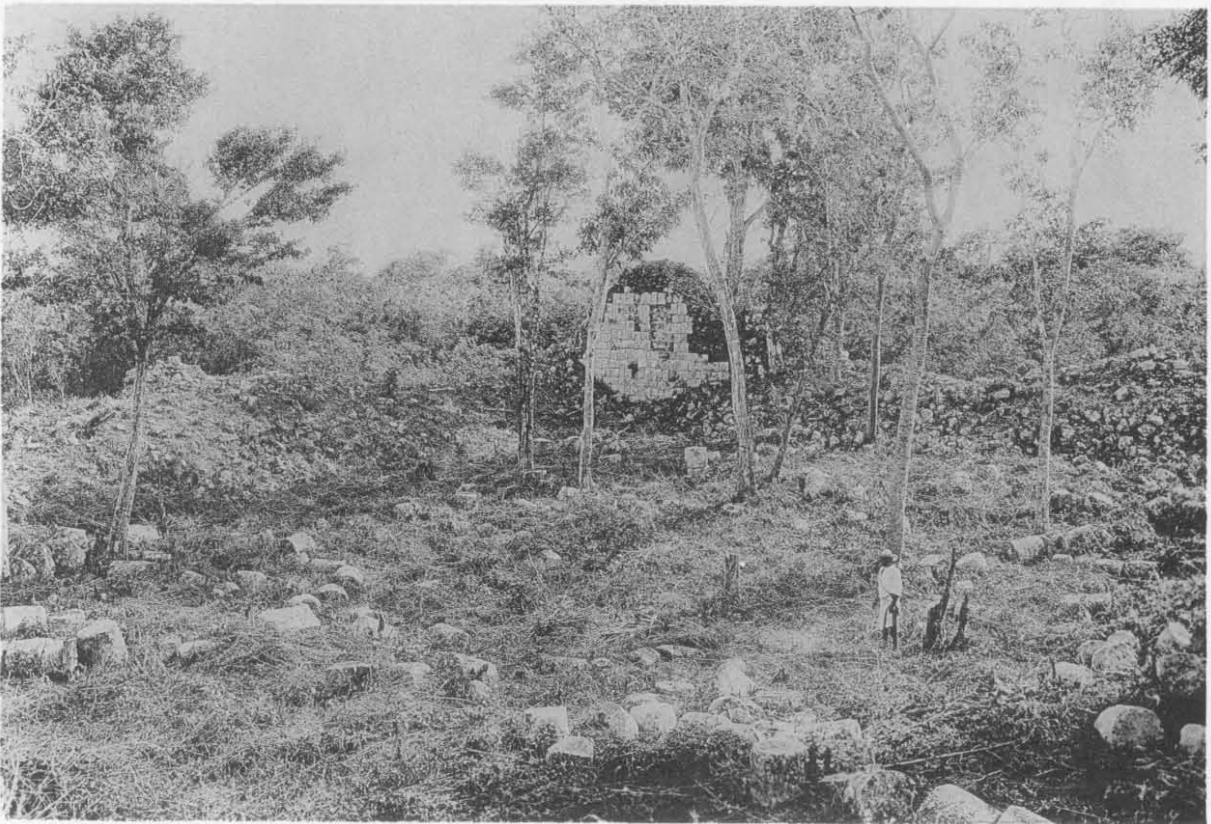
FIG. 29—PATIO INTERIOR  
*a*: Before excavation, looking west.  
*b*: Before excavation, looking southeast.

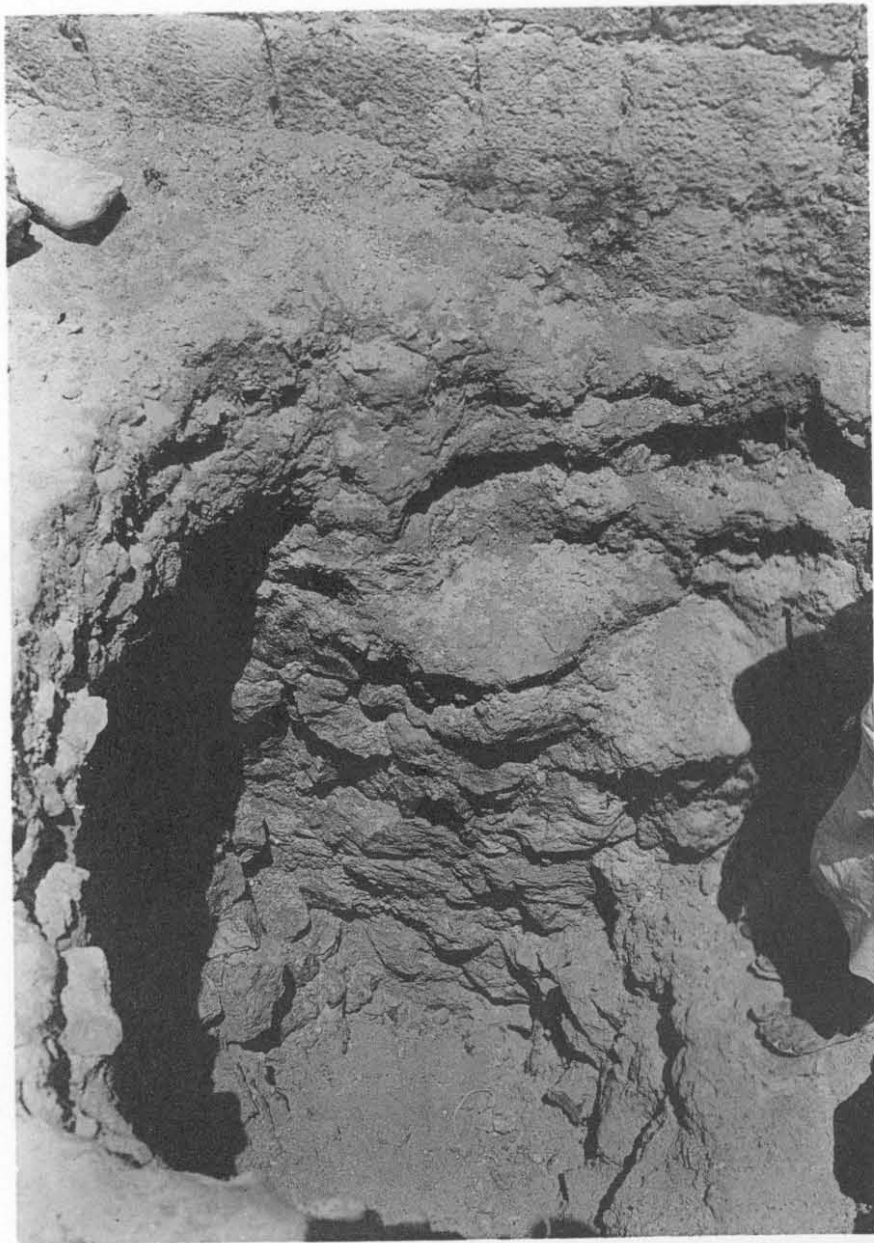
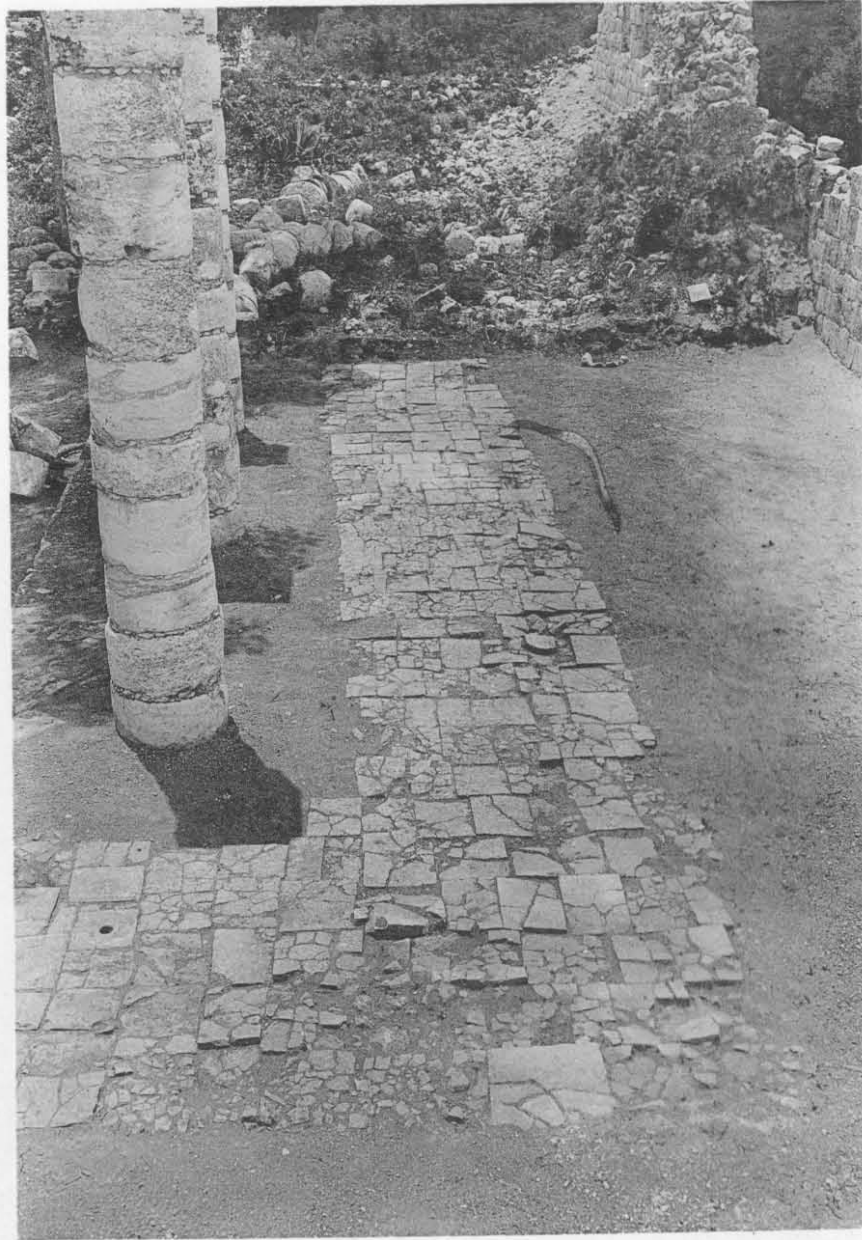
FIG. 30—PATIO INTERIOR

*a*: Northwest corner. Pit to examine fill.

*b*: South side looking east. Flagstone path calcined and broken as result of fire.

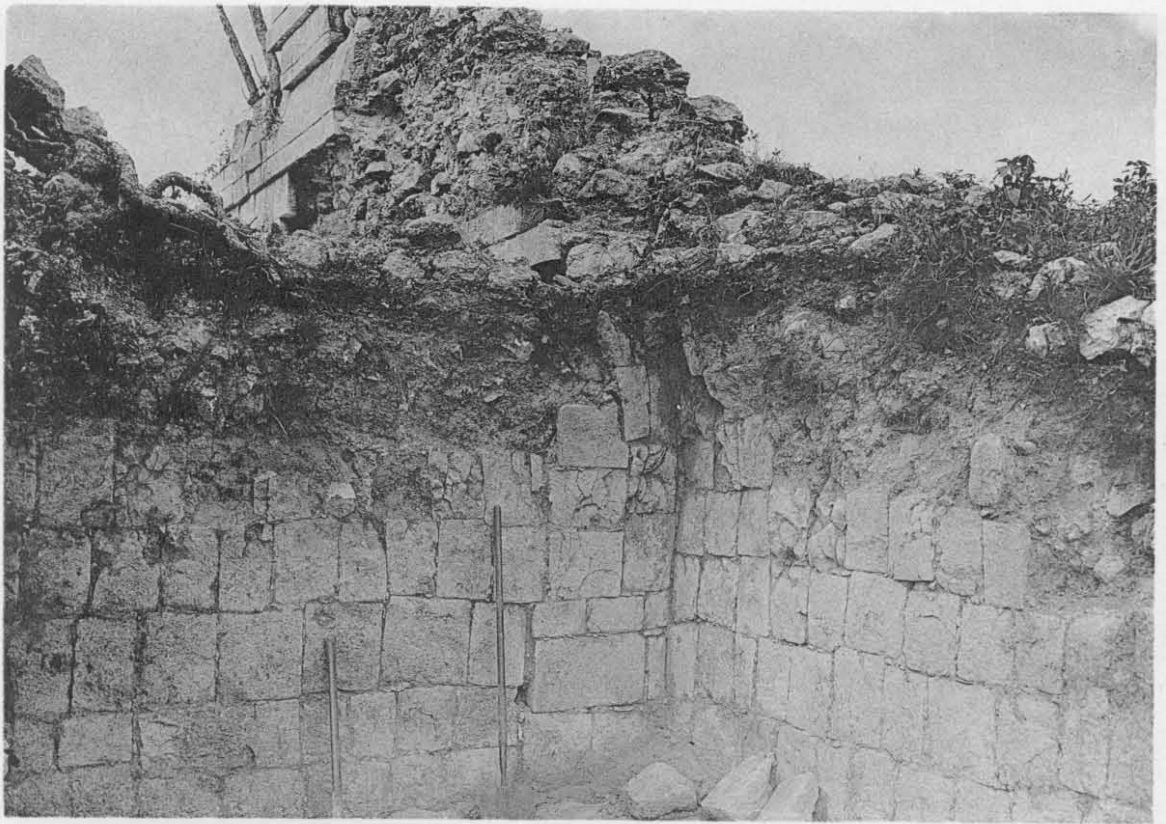
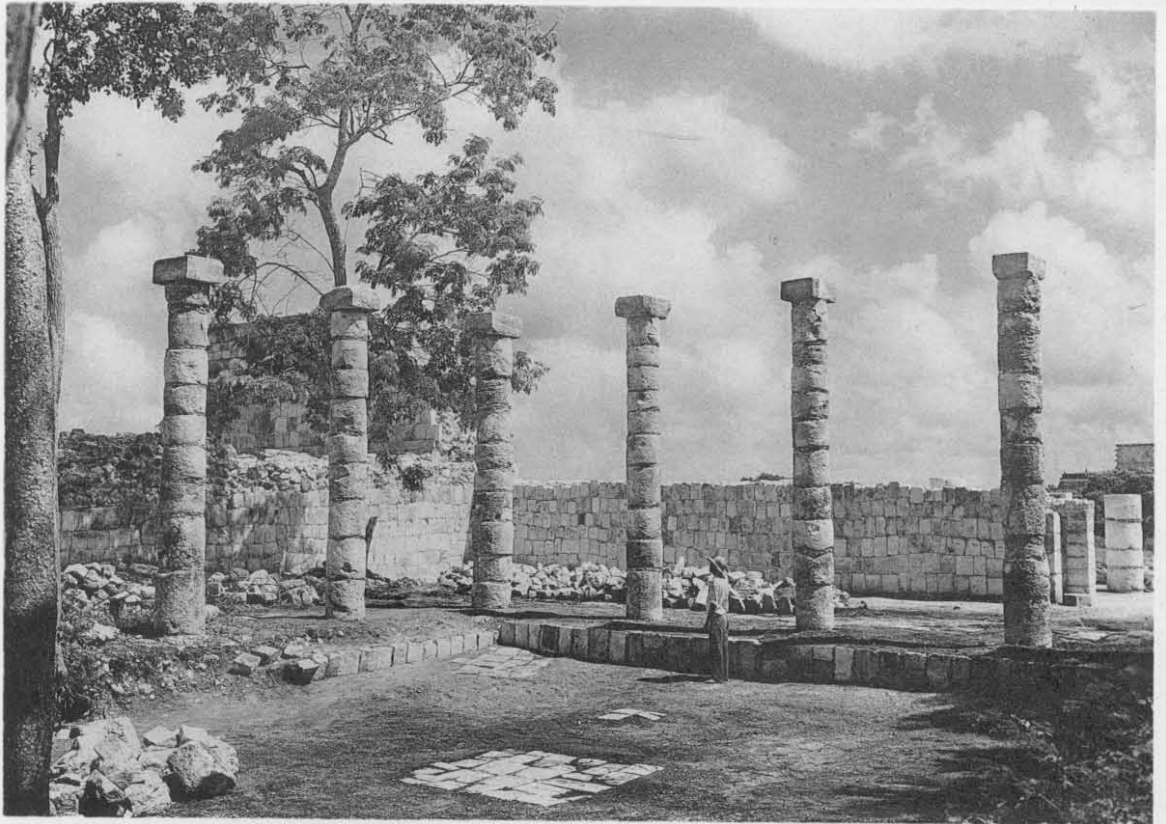
FIG. 31—PATIO INTERIOR

*a*: Northwest corner. Wall stones are calcined and broken as result of fire.  
*b*: Looking northwest. Columns re-erected.

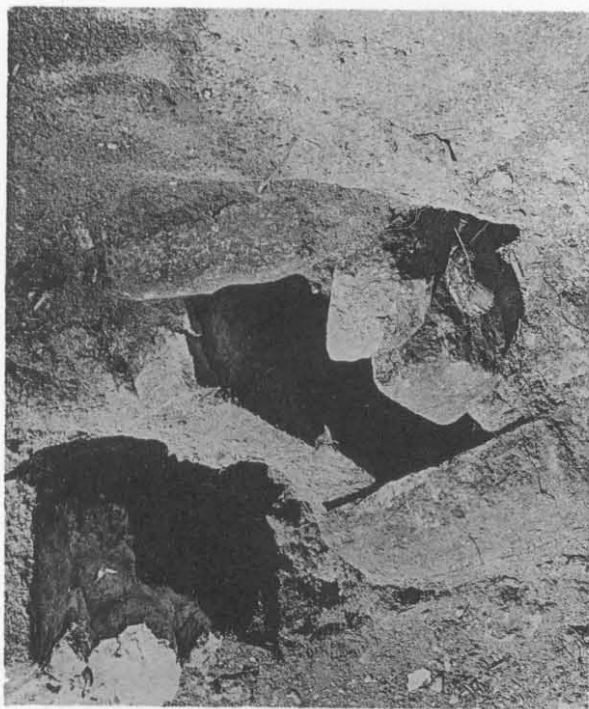
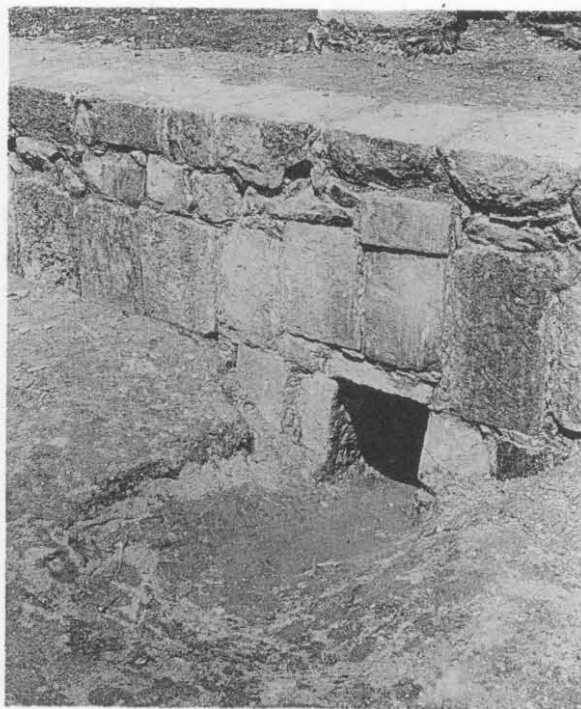
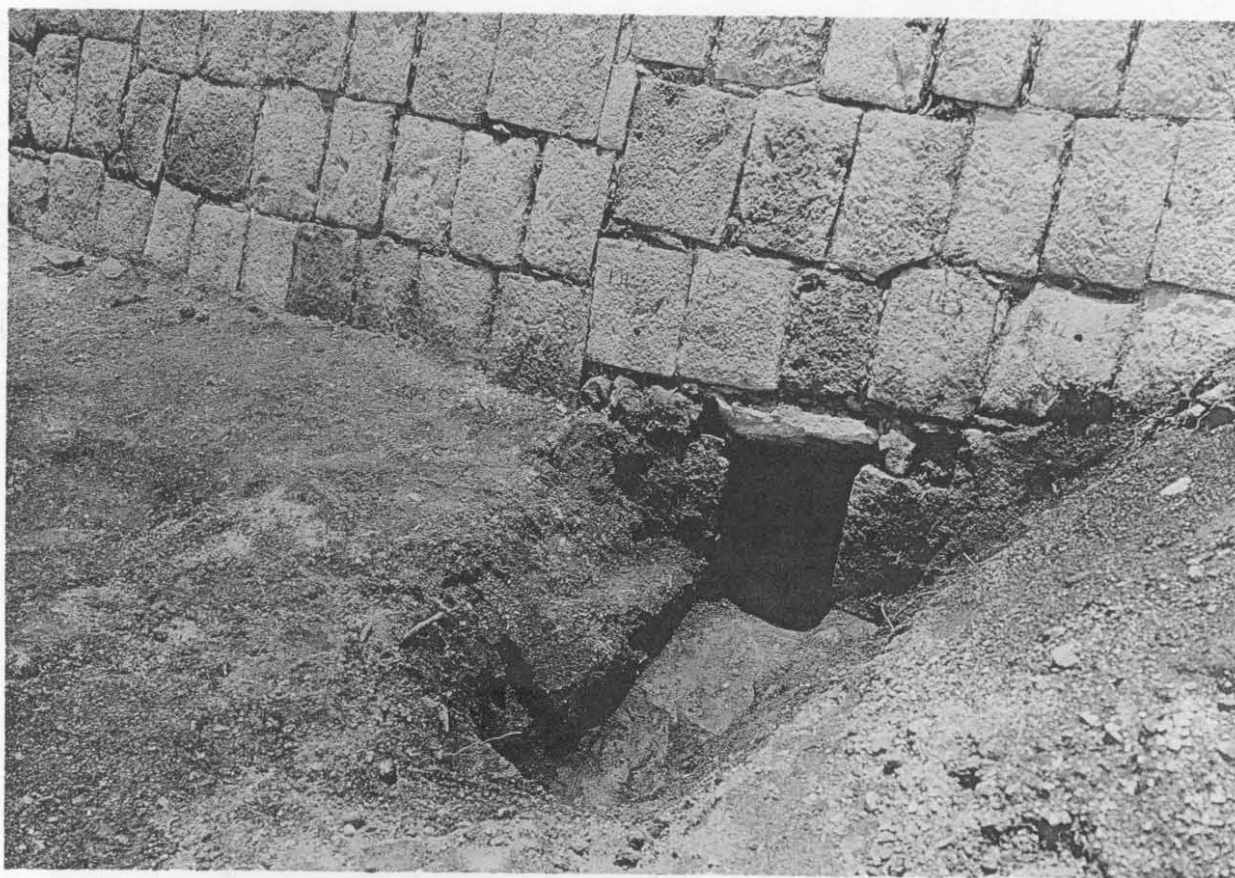
FIG. 33—PATIO DRAIN

*a*: Orifice of drain, west side of sunken area. Before repair.

*b*: Orifice of drain, west side of sunken area. Repair completed.

*c*: Drain from sunken court extends under the ambulatory and opens at base of west facing of patio platform.

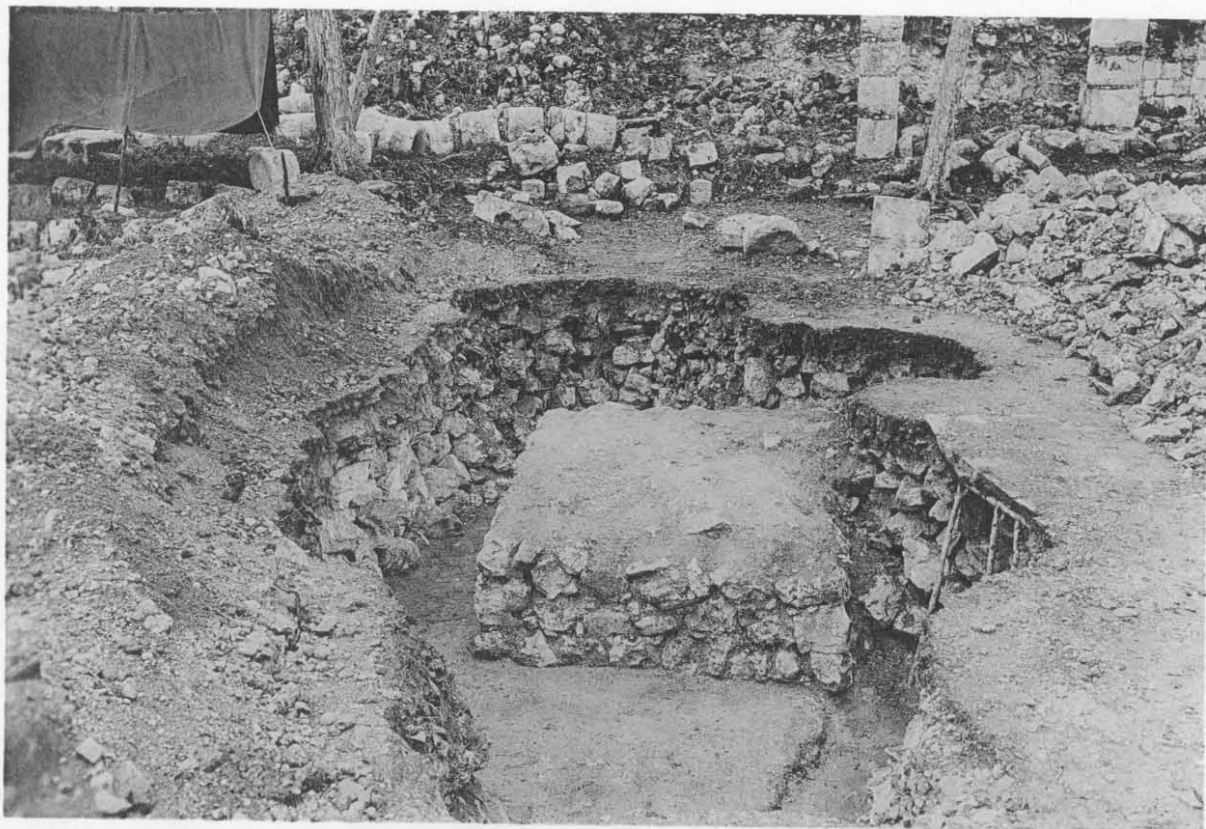
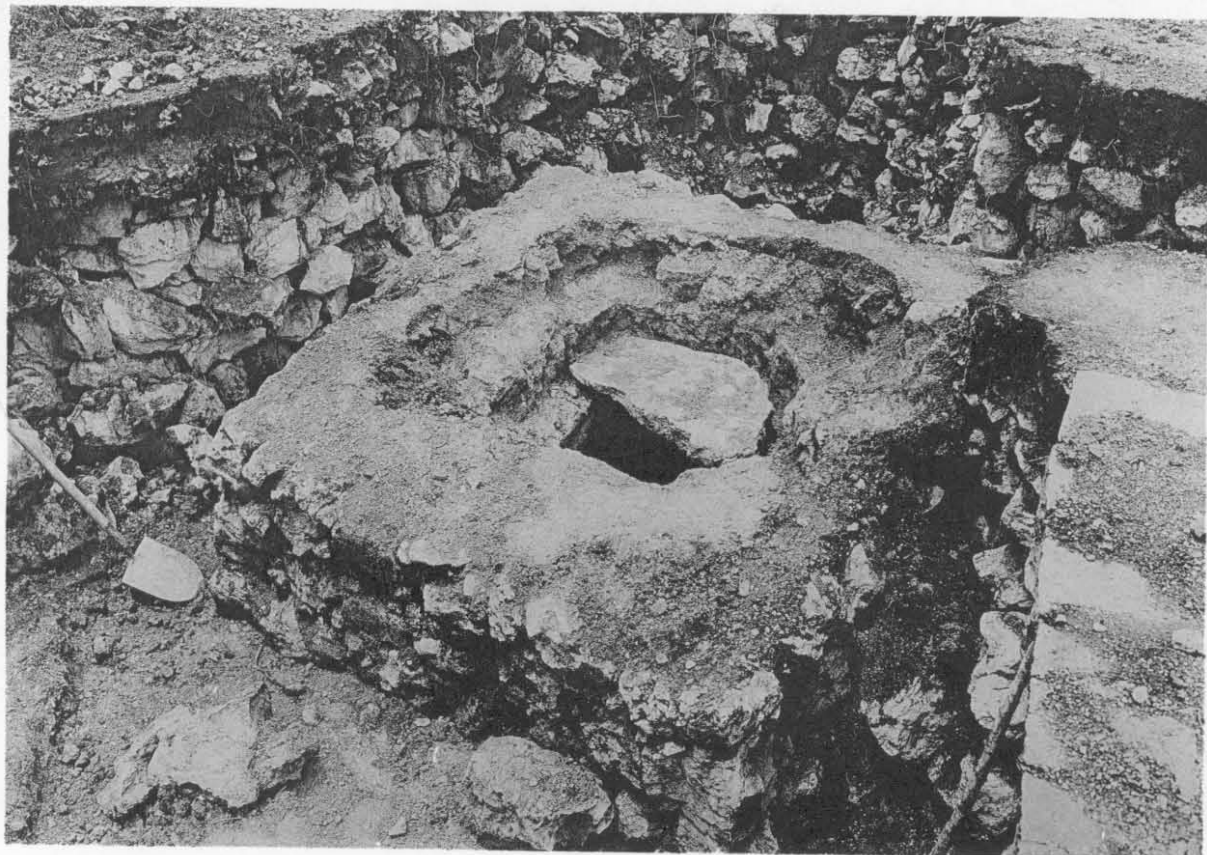
FIG. 34—MASONRY BOX UNDER FLOOR OF SUNKEN AREA OF PATIO  
*a*: View looking south.  
*b*: One of the two stones which formed the lid has been removed.

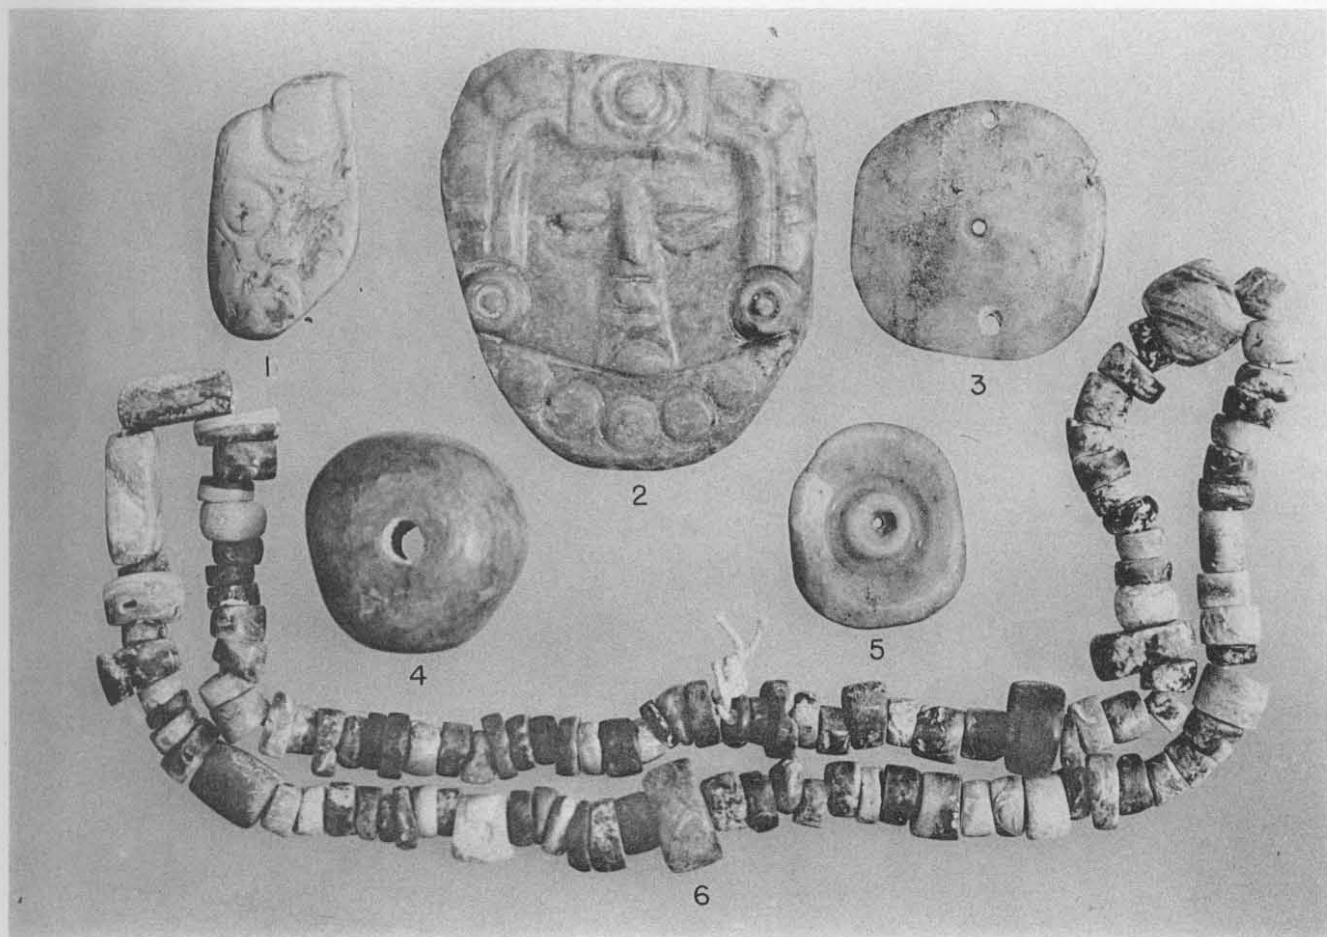
FIG. 35—MATERIAL FOUND IN MASONRY BOX

- 1: Piece of green stone.
- 2-5: Pieces of worked jadeite.
- 6: 113 shell beads.
